# Fulfilling the Promise of San Diego's Purple Pipe Program

Hooman Partow, City of San Diego Todd Engstrand, HDR Eric Scherch, HDR

## 2018-2020 Recycled Water System Condition Assessment and Optimization Plan

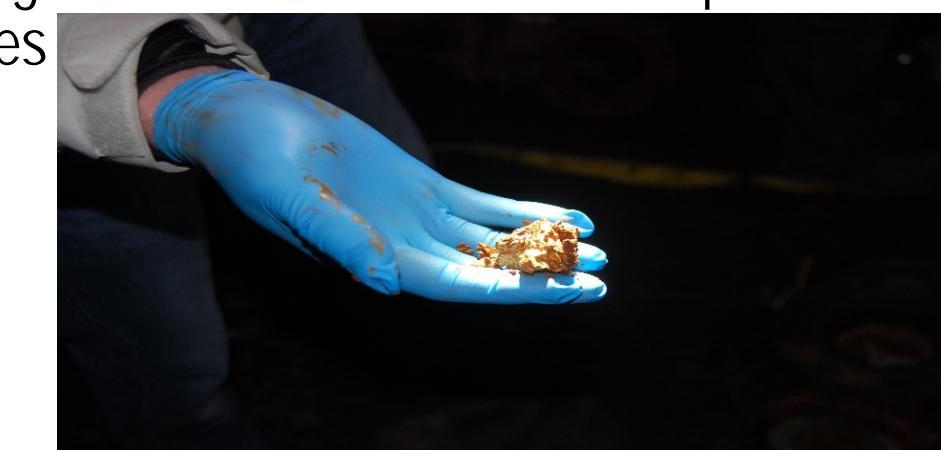
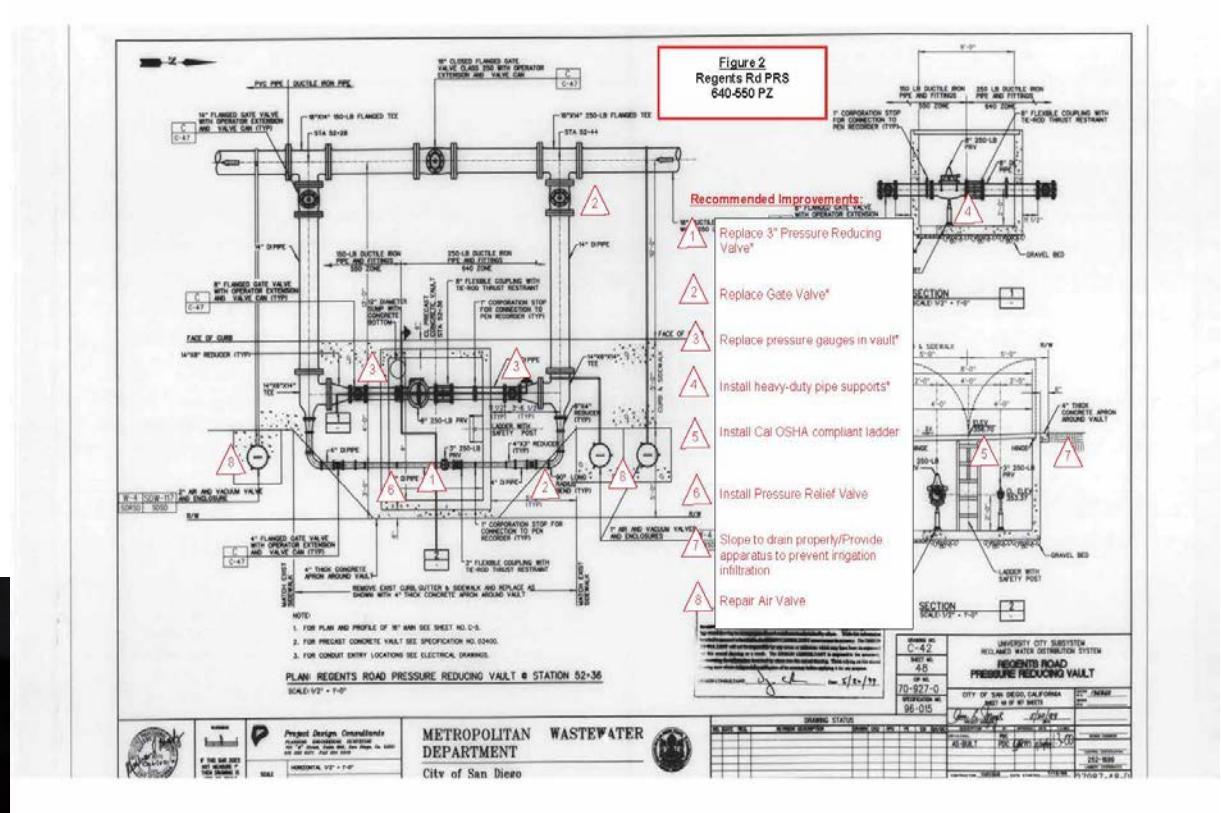
- 13 Pressure Reducing Stations Varying States of Condition
- 25% Transmission Non-Operational
- 22% Distribution Non-Operational
- 41% Air Valve Non-Operational
- Valve Exercising Program
- Orange and Black Material Build Up In Valves

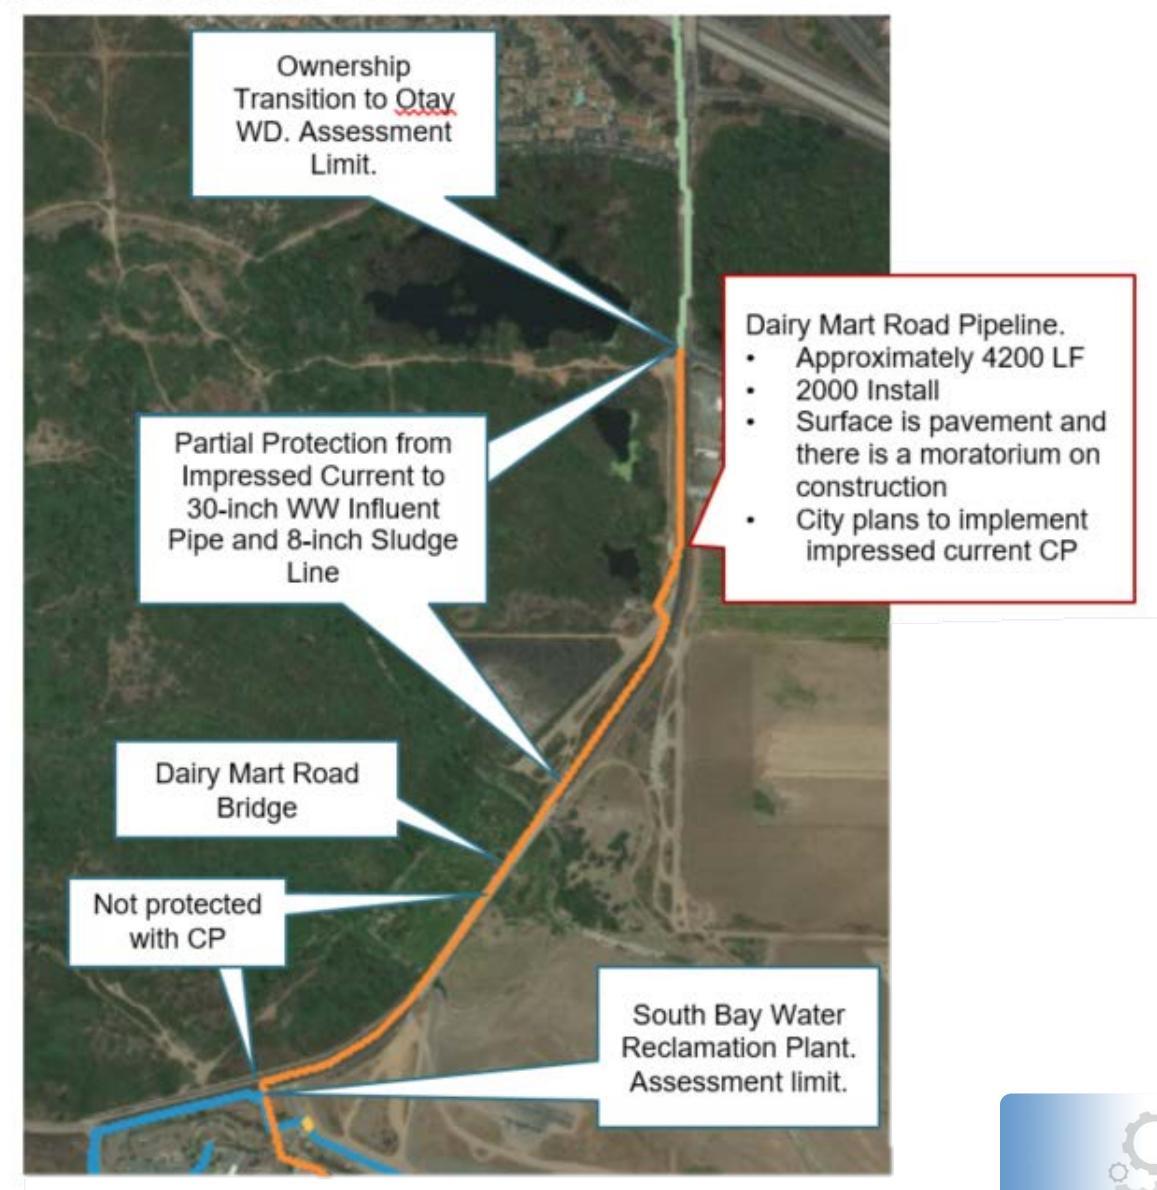
Dairy Mart Road Pipeline - 30-Inch Ductile Iron

- Risk model prioritized pipelines for condition assessment evaluation
- Soil corrosivity survey for 30-inch DIP along Dairy Mart Rd
  - Identifies soil corrosivity hot spots
  - Supports future cathodic protection implementation
