Case study of a successful in-plant water reuse project that solved the water shortage problem while providing a good payback for a major petrochemical plant

Joseph Wong, Brown and Caldwell

WaterReuse Association

February 21, 2014

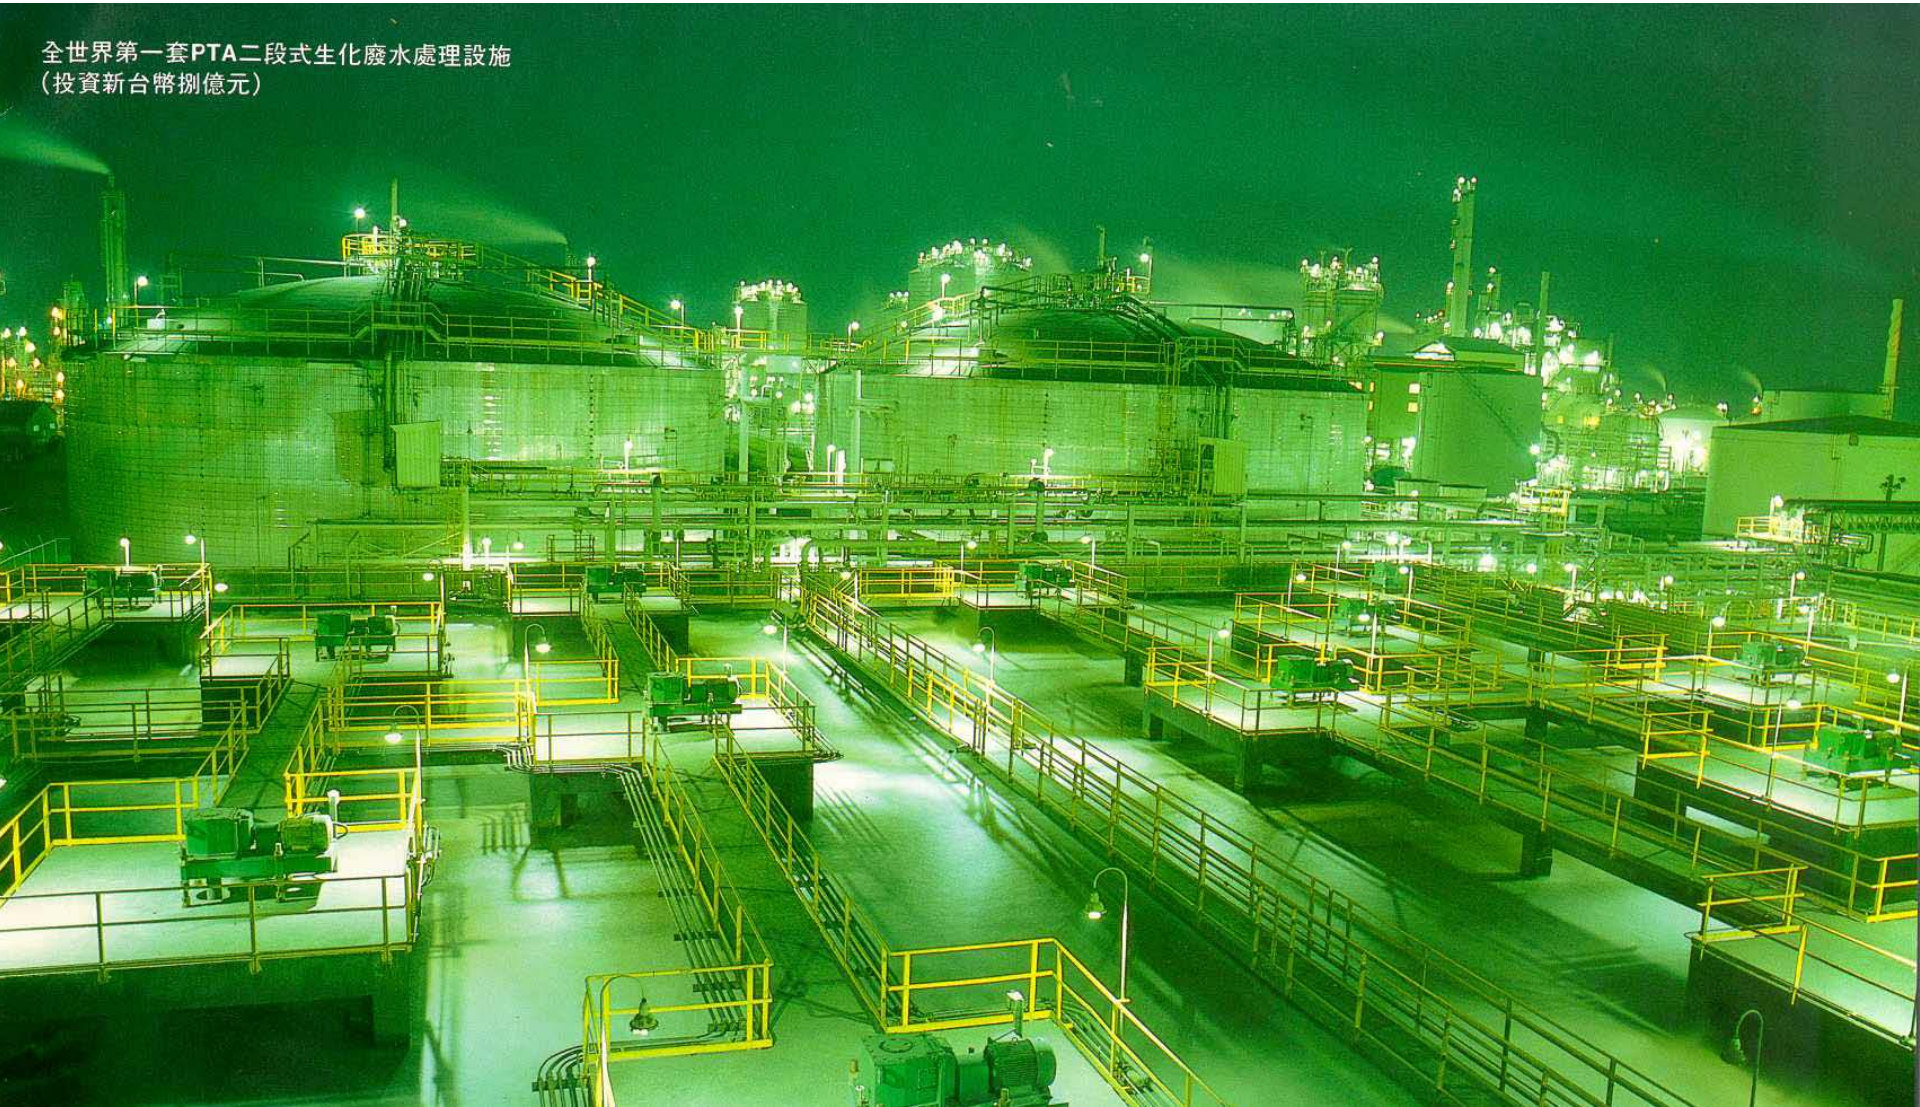
Two Stage Anaerobic-Aerobic Organic Wastewater Treatment System

全世界第一套PTA二段式生化廢水處理設施
(投資新台幣捌億元)

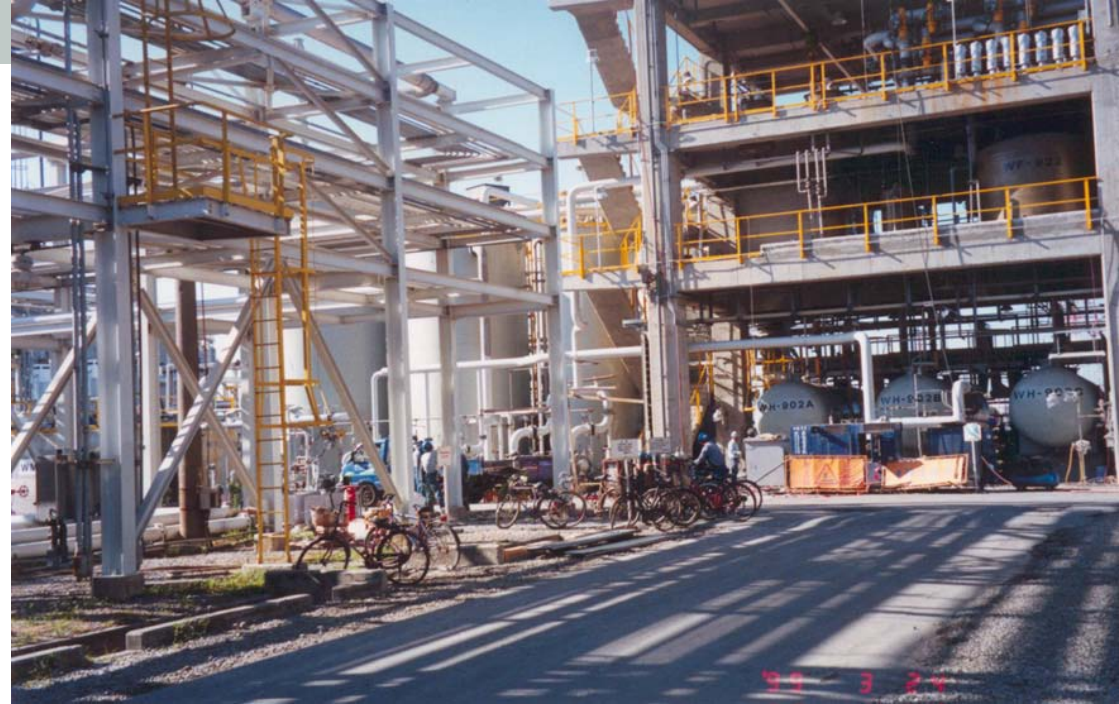
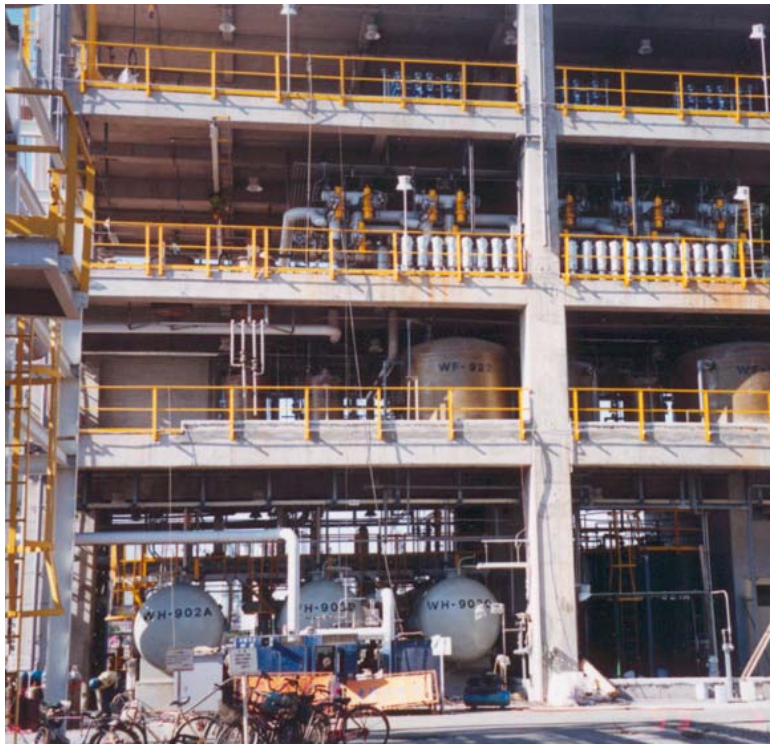
Full Scale Plant

Four-Story Building

- First Phase: 9,000/6,600 cmd
- Design/Build: 2 Years
- Space Limitation: Four-Story Building
- Capital Cost: US\$15 Million
- Commissioned: April 2000

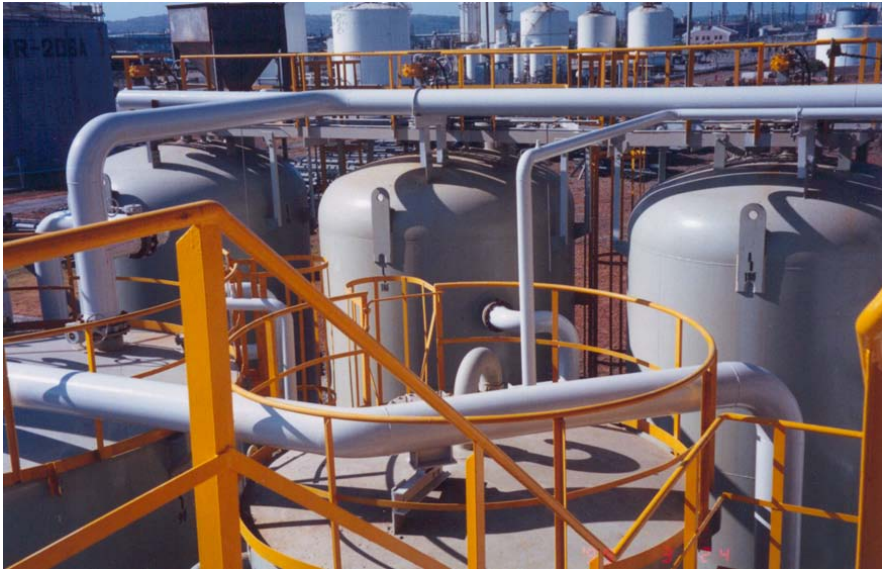
Vertical GAC Filters

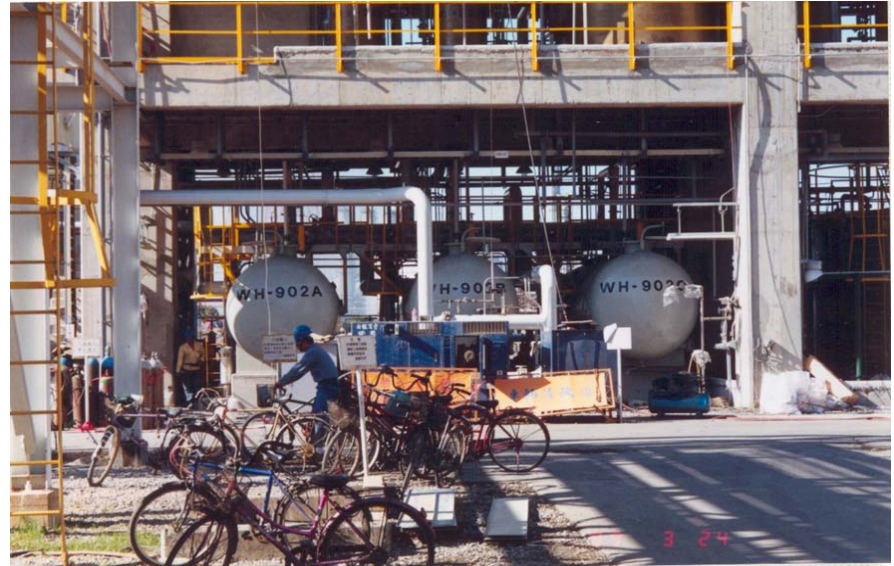
Horizontal Dual Media Filters

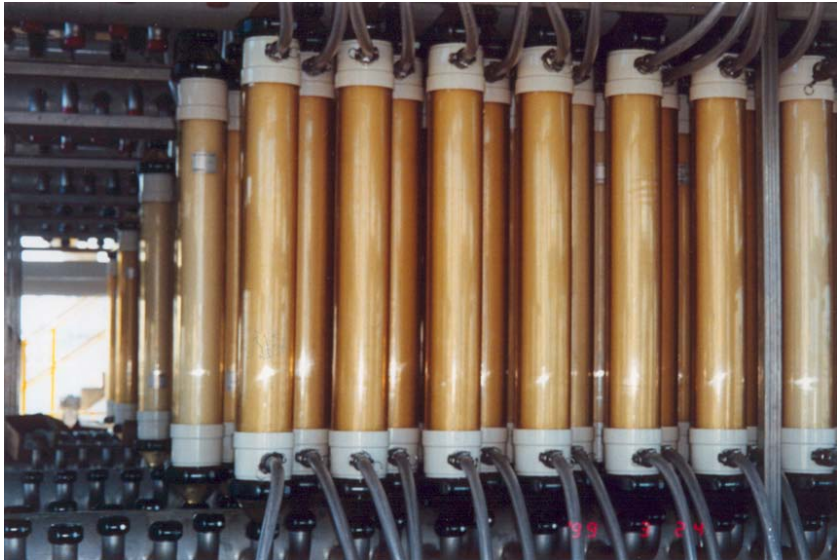
UF Cartridges
(Koch PM100)

- Flux: 85.9 L/m²/h (50.6 gfd)
- Recovery: 92%
- Effluent Turbidity: <0.1 NTU
- 5 Koch UF Skids – Each w/ 109 6-inch PM100 Cartridges
- CIP Frequency: 4 Weeks
- Average Membrane Life: >6 Years
- Converted to 10-in Cartridge System (Still in Use after 6 years)

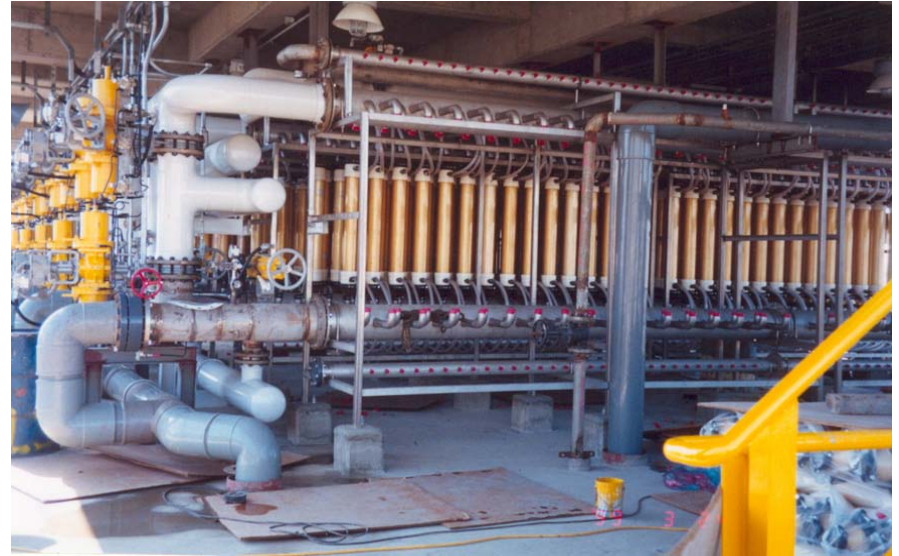
UF System
(6-inch Cartridges)

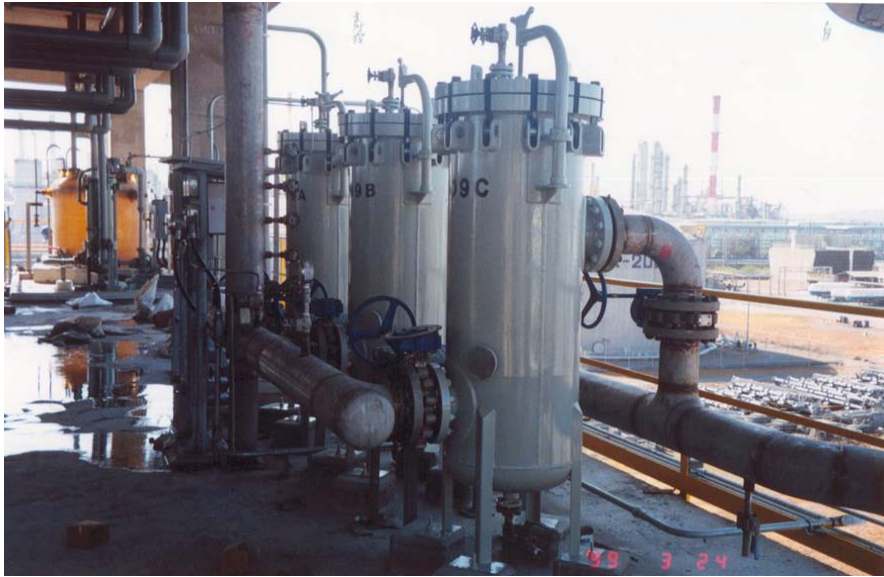
RO Prefilters

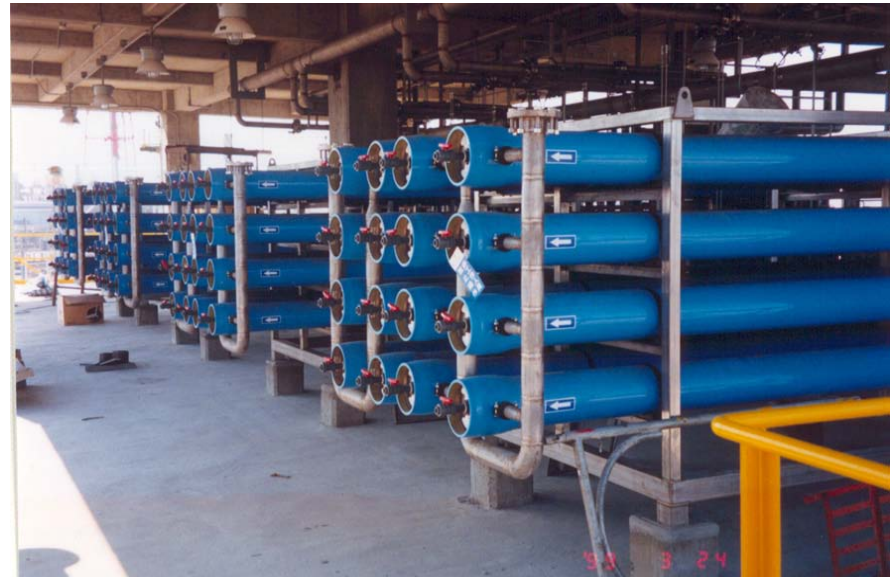
RO Skids

- 8 Trains of 2-Stage RO w/ 5:3 Array
- Membrane: Filmtech BW30-400
- Flux: 22 L/m²/h (13 gfd)
- Recovery: 80%
- Initial Chlorine Oxidation Caused Replacement of Membranes in 5 Trains
- Subsequent CIP Frequency: 1 years
- Average Membrane Life: >4 Years

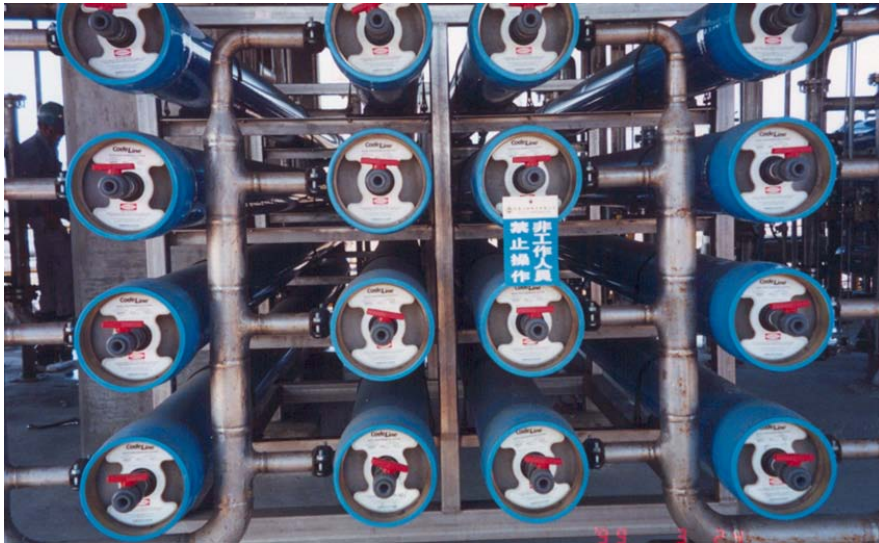
RO Modules (FT BW30-400)

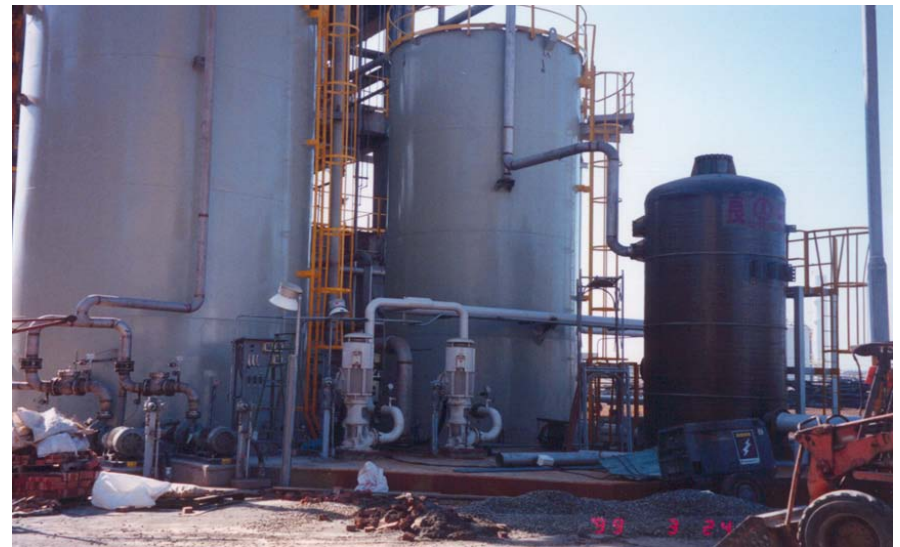
RO Tanks with Degasifier

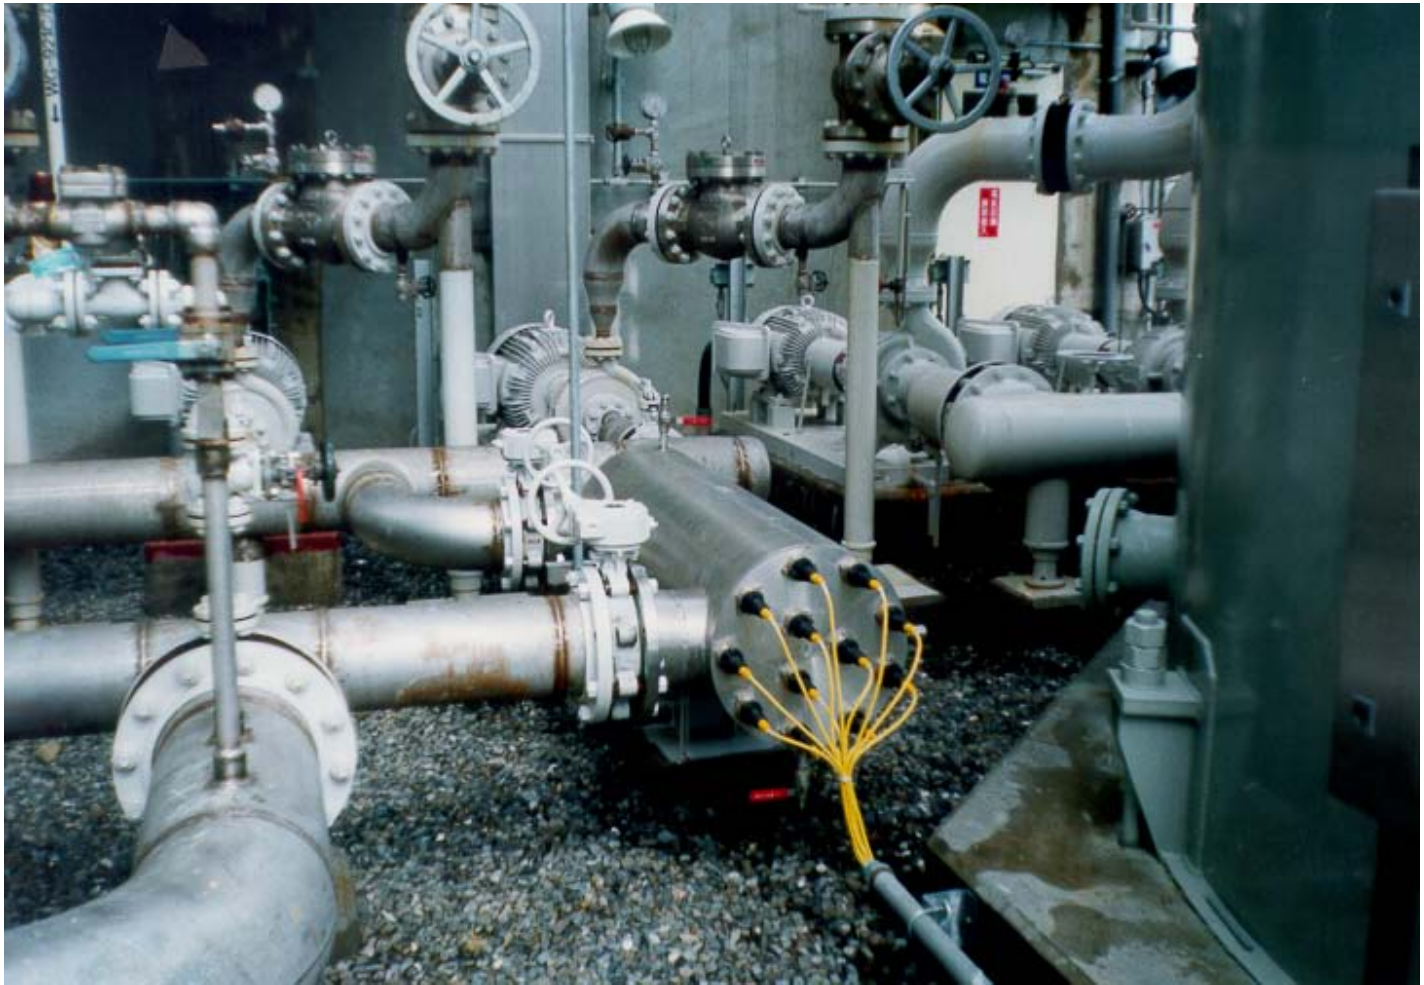
UV Disinfection System

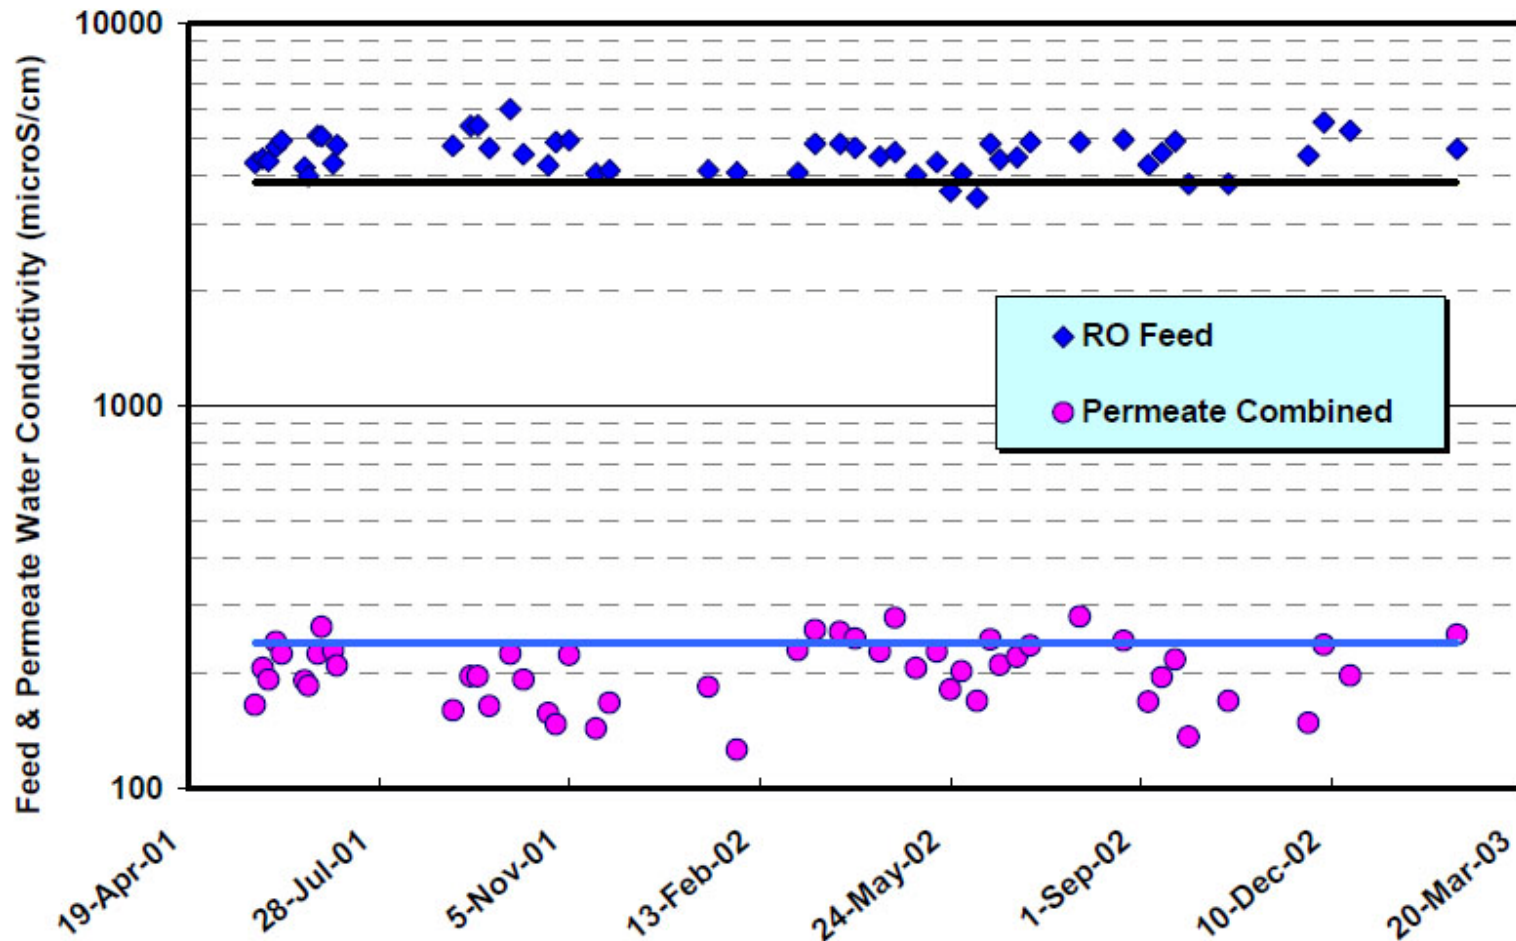
Conductivity of RO Feed and Combined Permeate - Typical

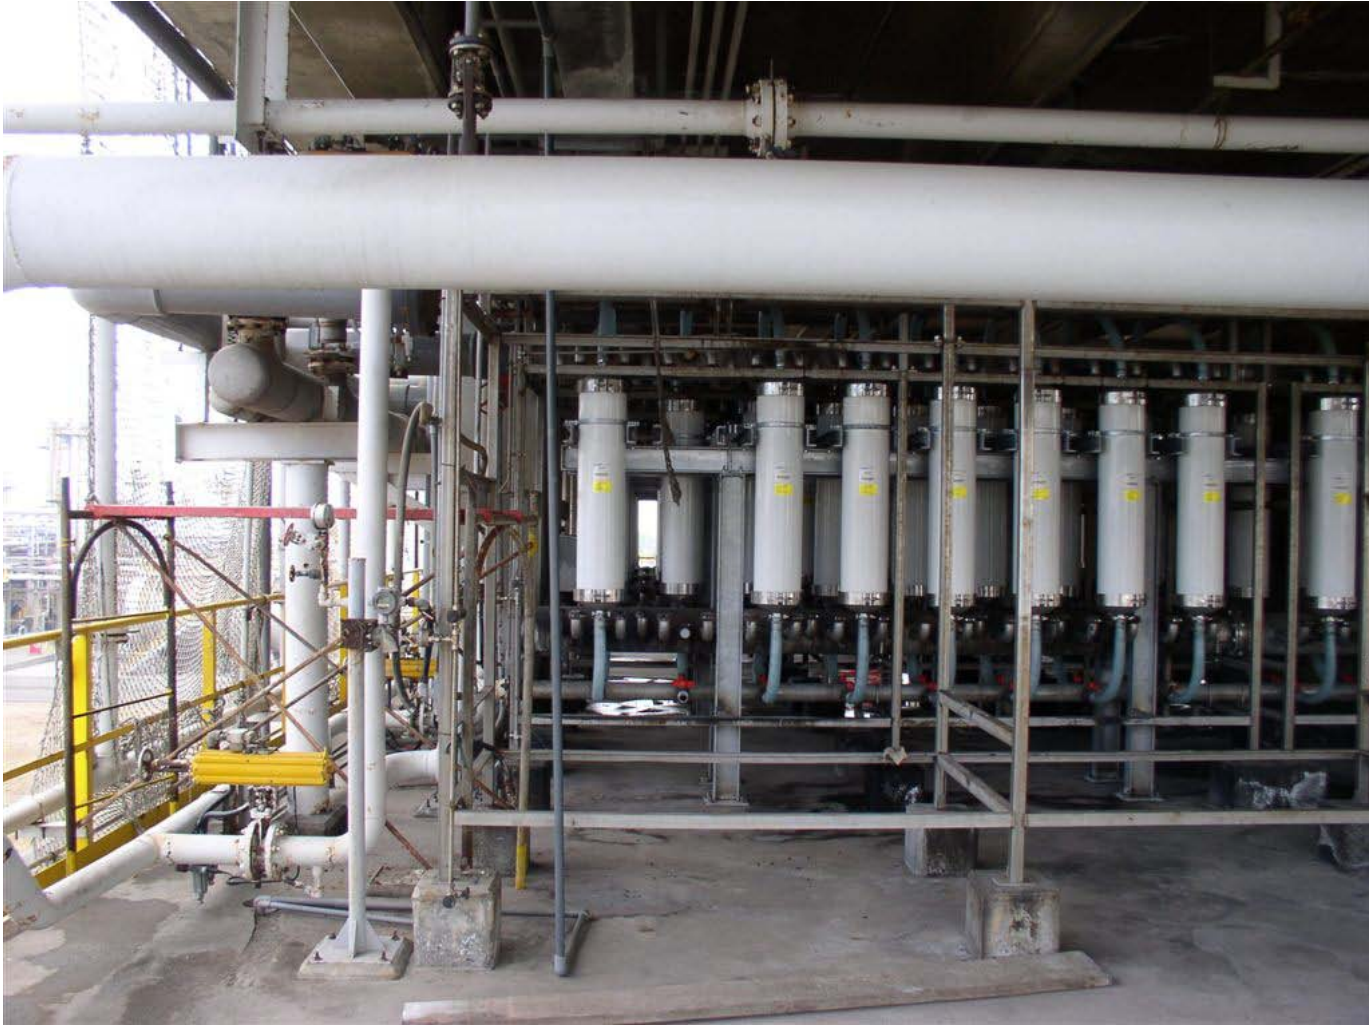
Converted 10-inch UF System (1)

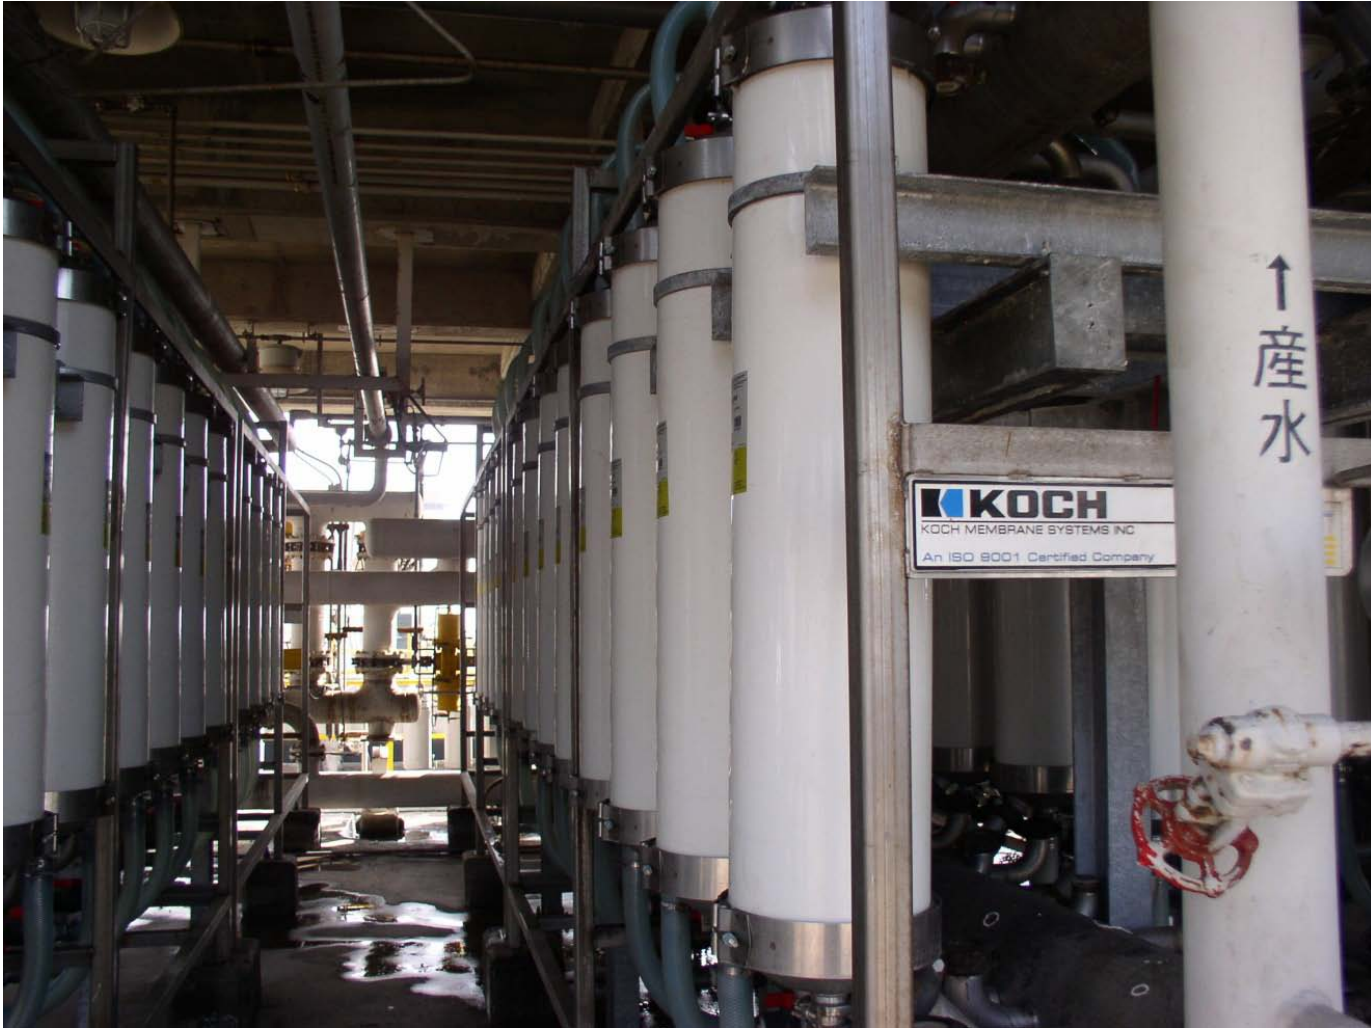
Converted 10-inch UF System (2)

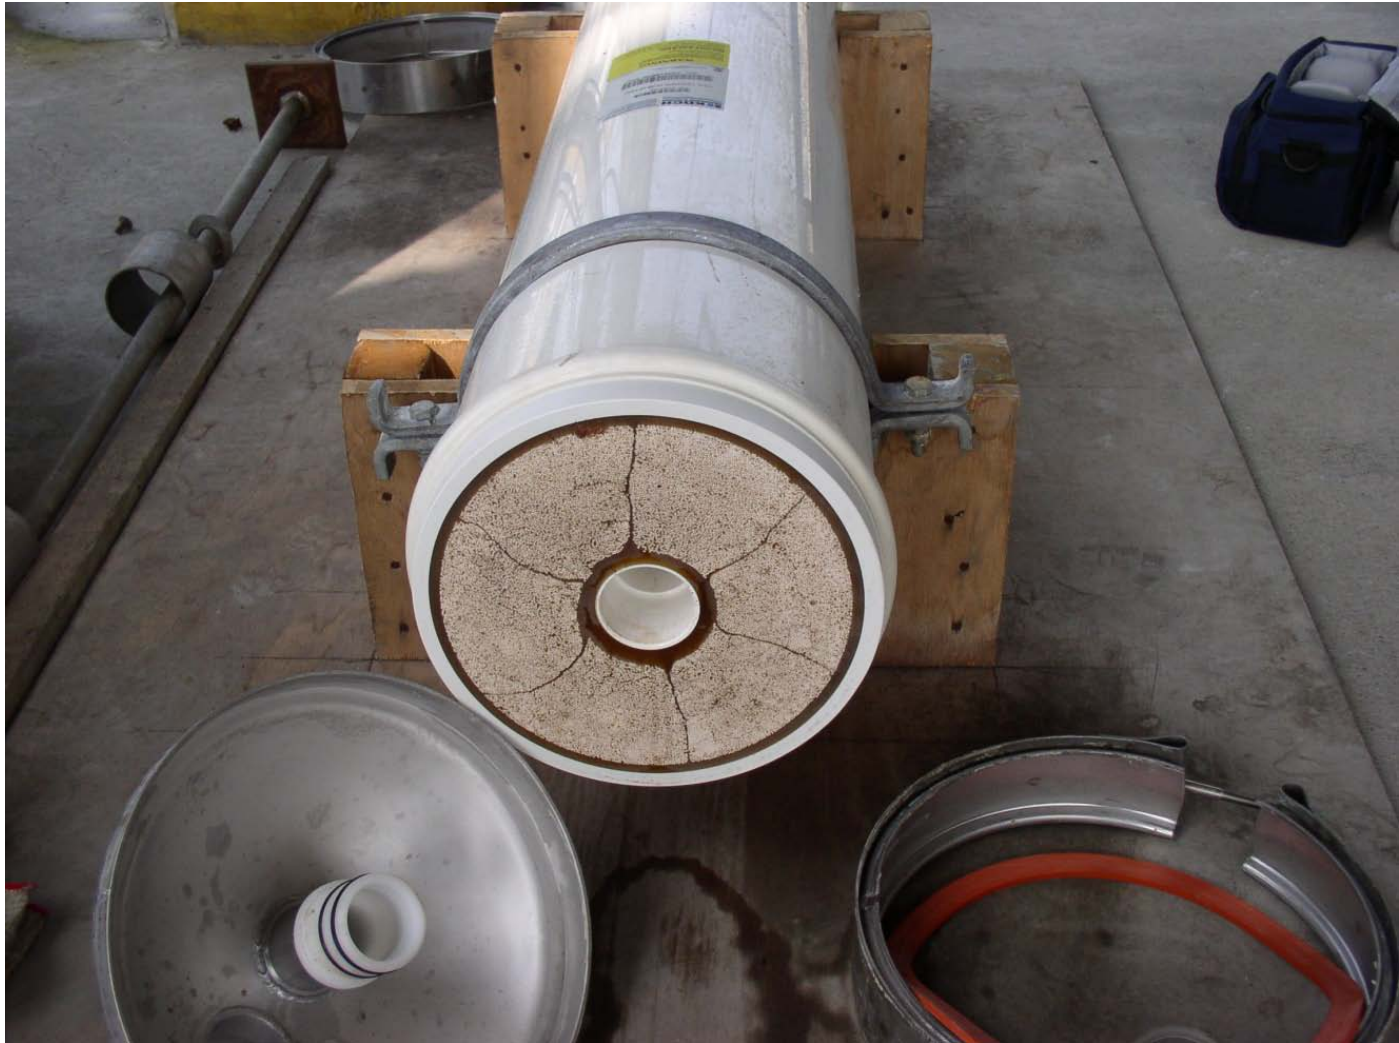
10-inch Koch UF Cartridge
