Oroville Spillway Incident

Bill Croyle
Retired Acting Director
California Department of Water Resources

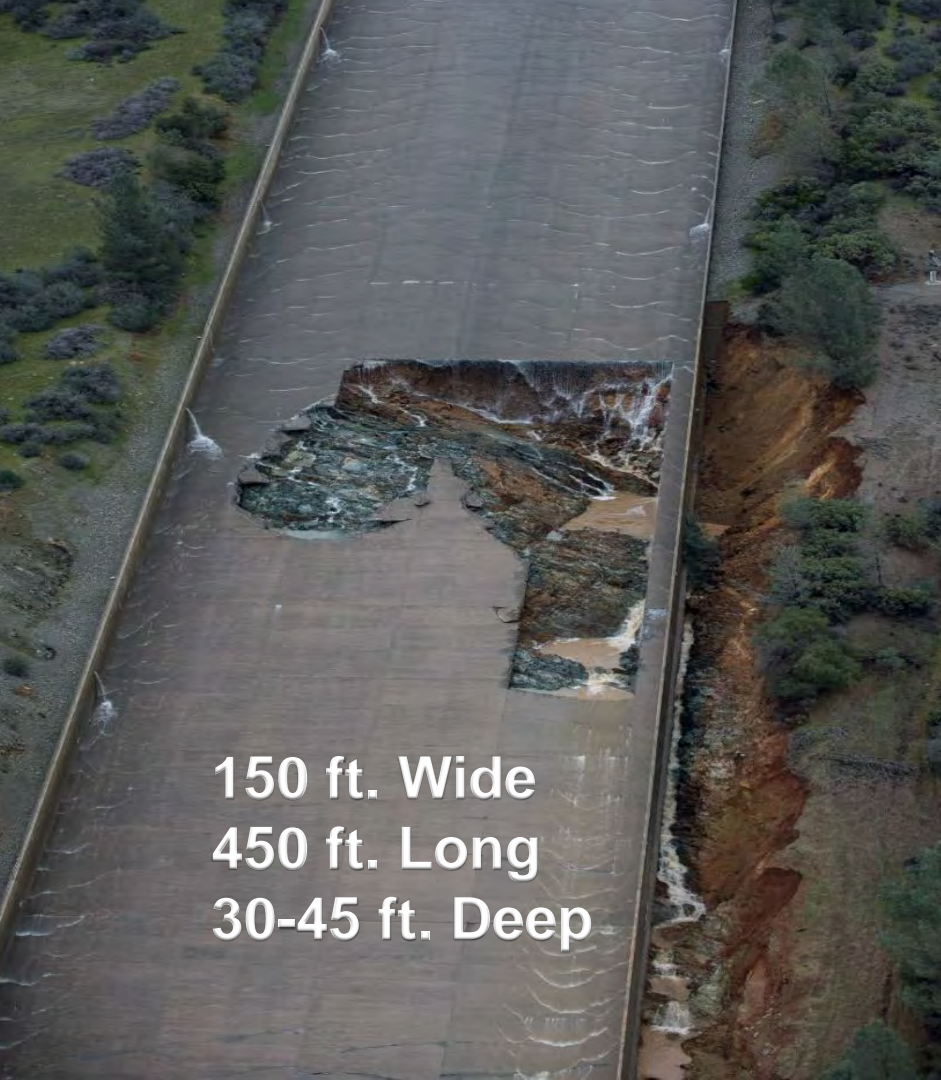
Deck and Foundation Erosion

150 ft. Wide
450 ft. Long
30-45 ft. Deep

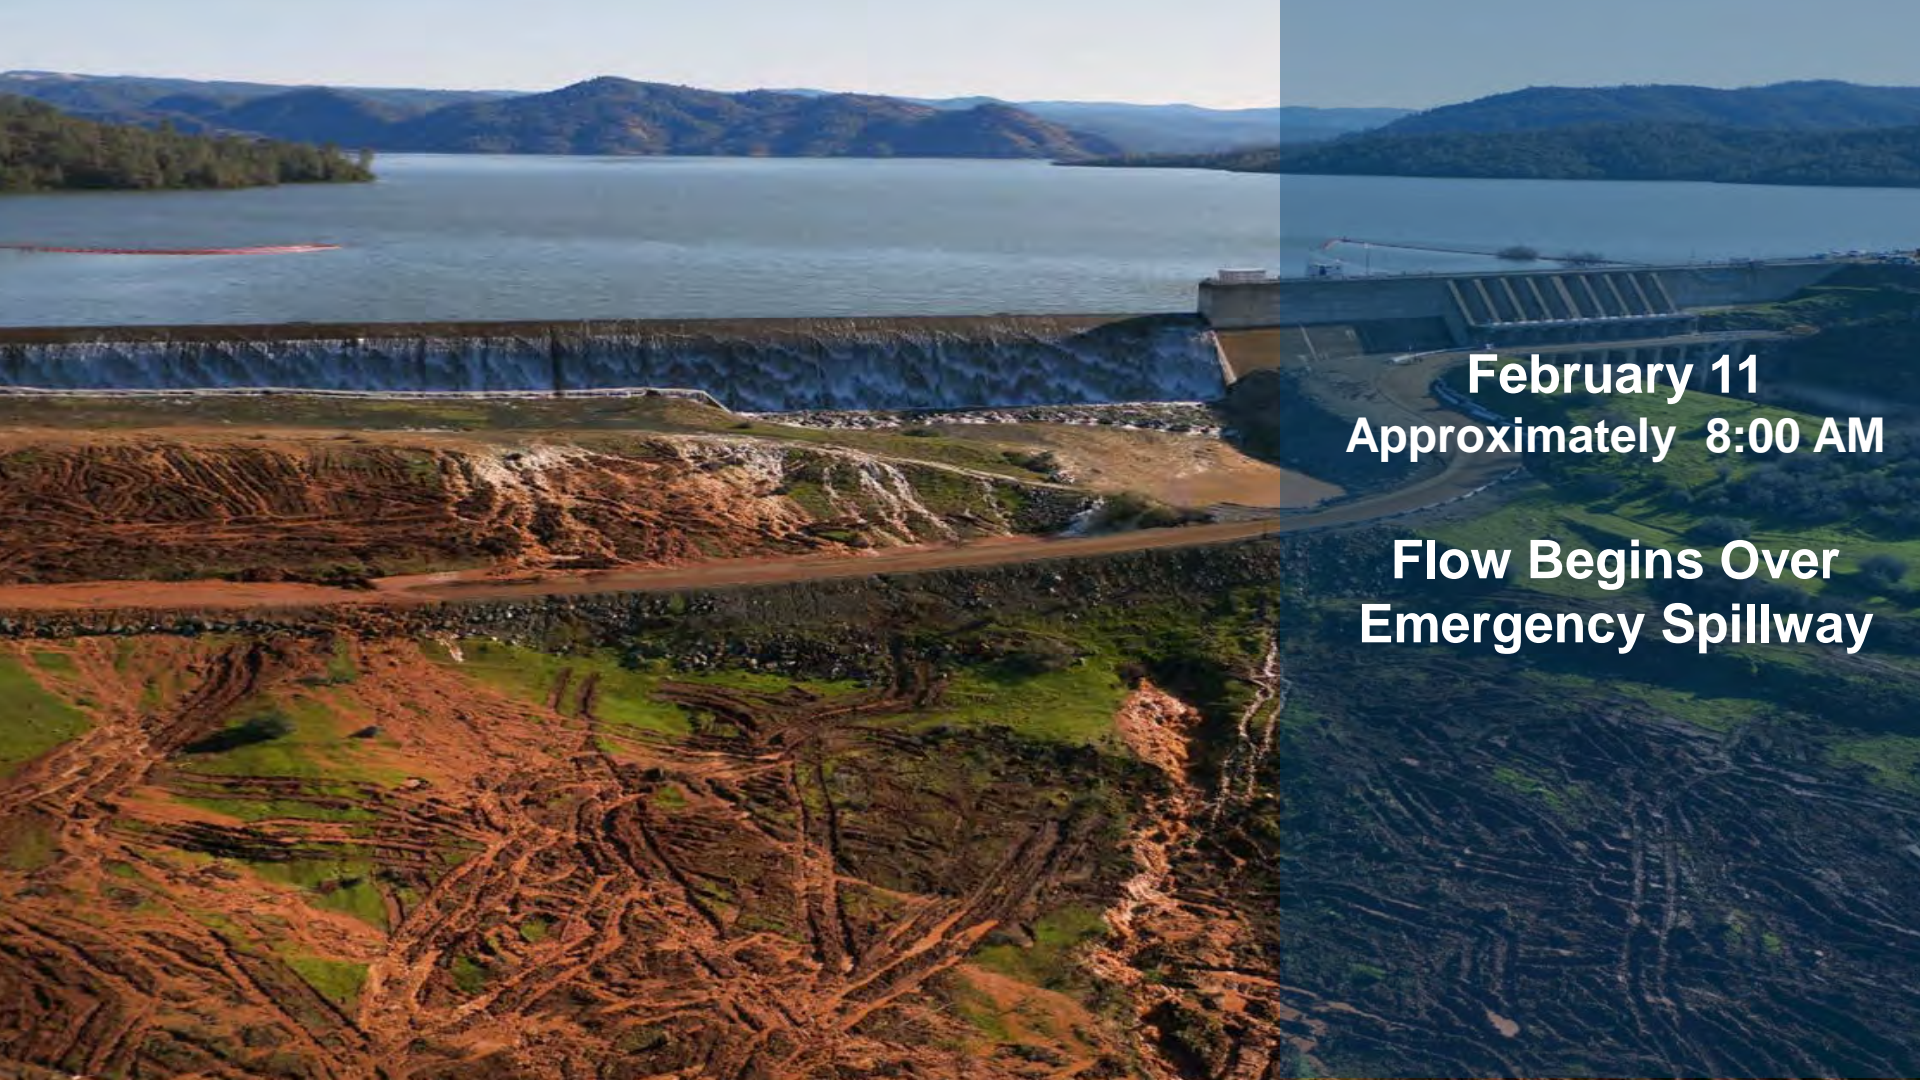
February 11
Approximately 8:00 AM

**Flow Begins Over
Emergency Spillway**

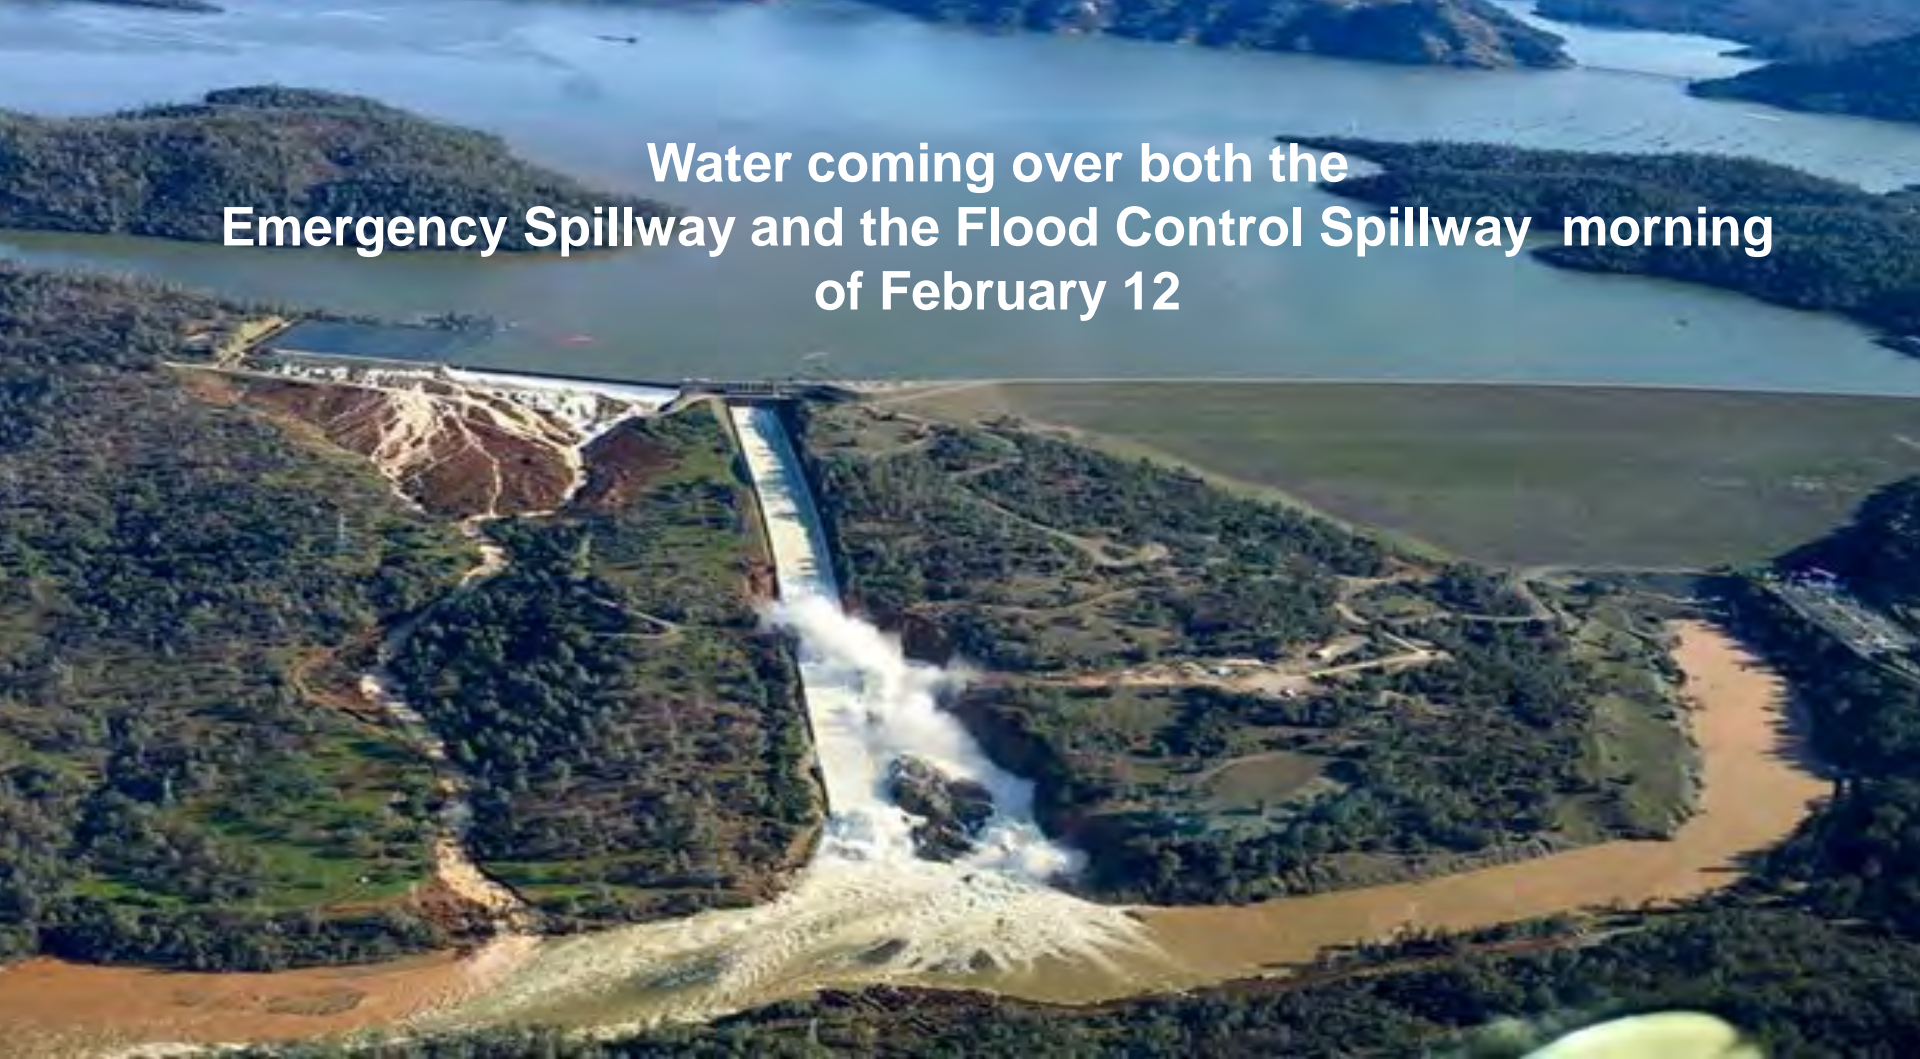
**Water coming over both the
Emergency Spillway and the Flood Control Spillway morning
of February 12**

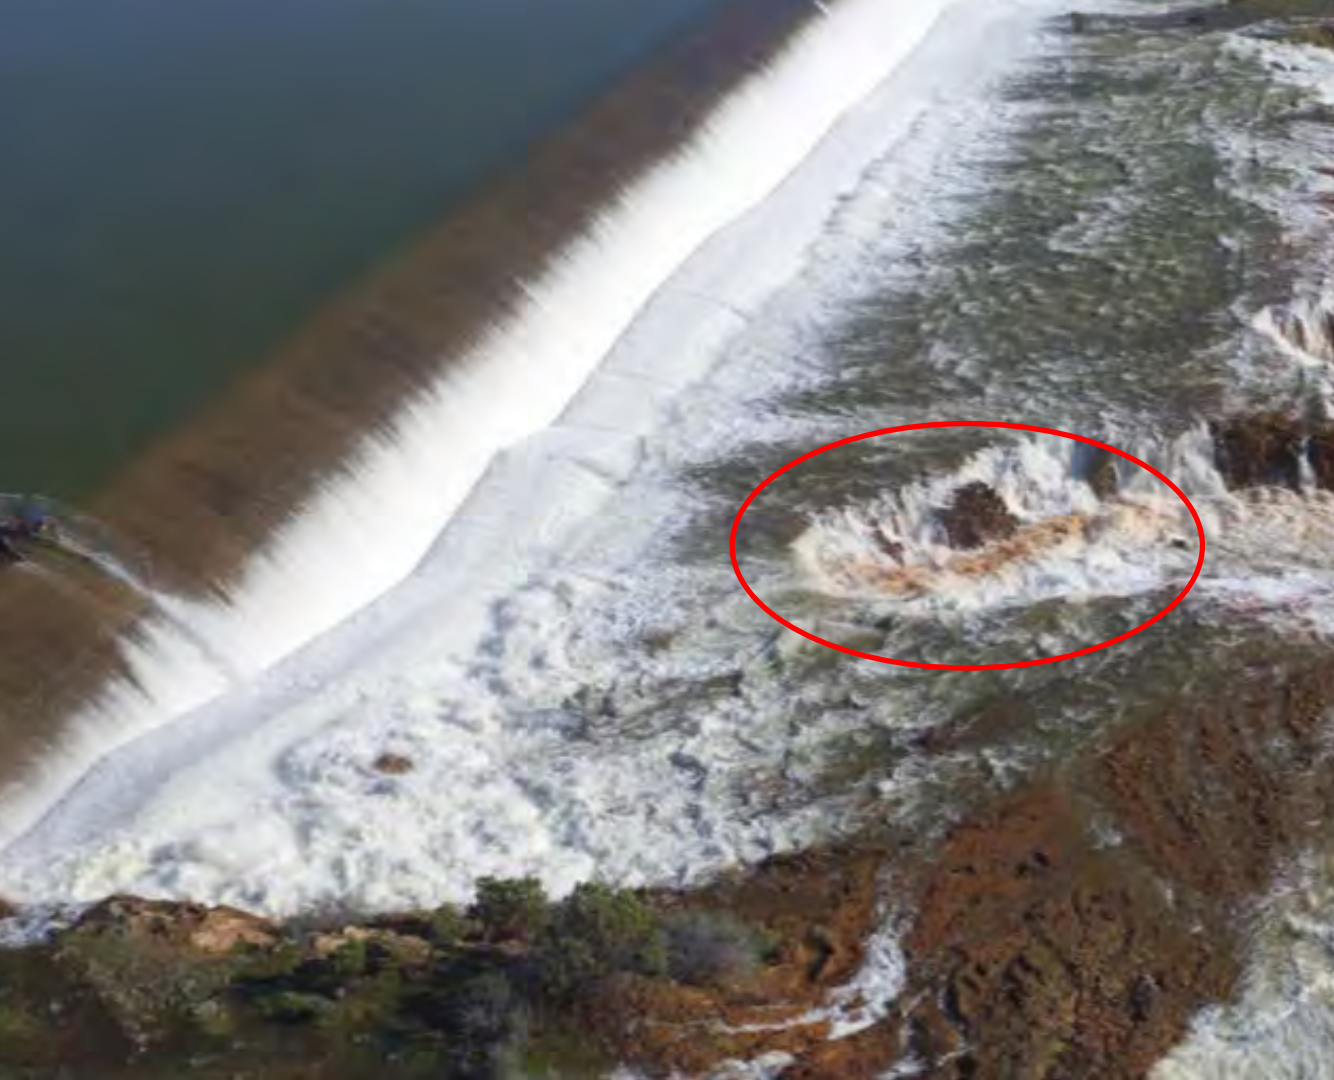
3:30 pm

- **Rate of Erosion
Began To Increase**
- **Moving Toward
the Emergency
S/W
at about
30 feet/hour**

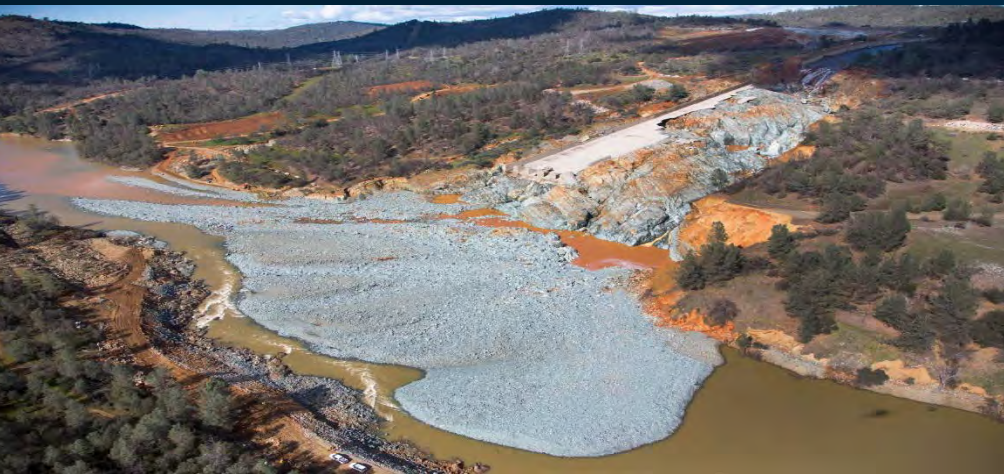
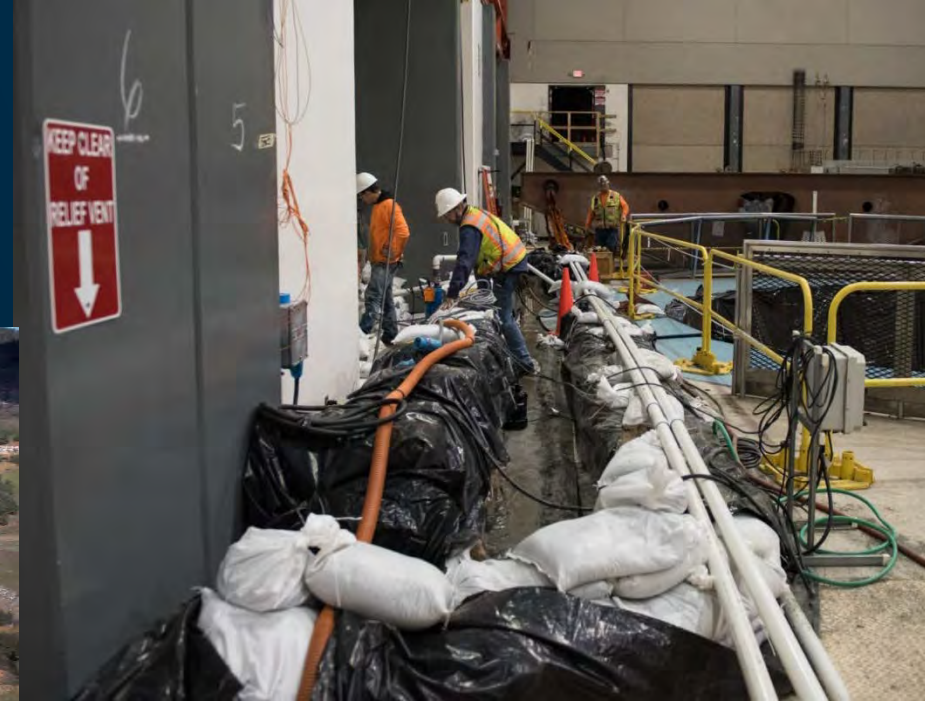
Flood Fighting at Hyatt Powerplant

Rock and concrete collected in the diversion pool, causing flood risk to Hyatt

Sandbagging, grouting, pumps, tanks, and other efforts by DWR staff and emergency response partners saved Hyatt

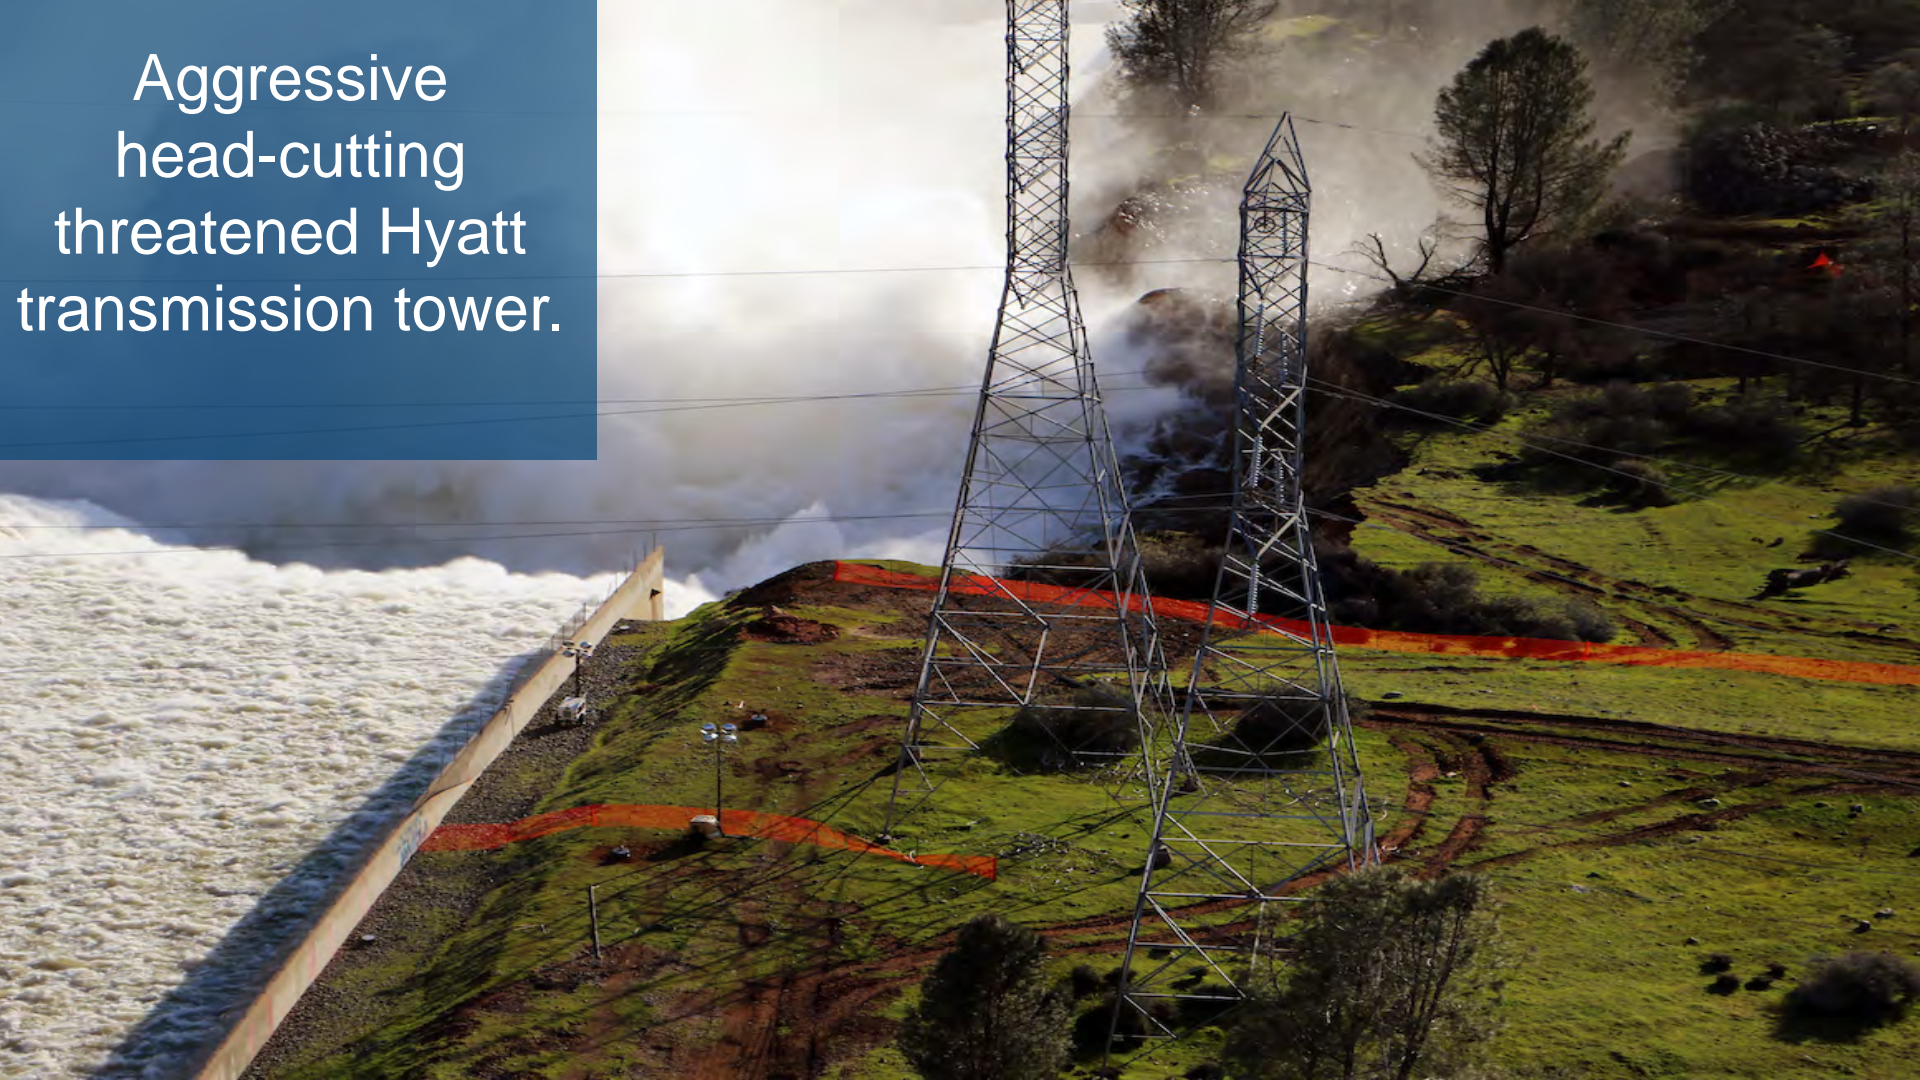
Aggressive
head-cutting
threatened Hyatt
transmission tower.

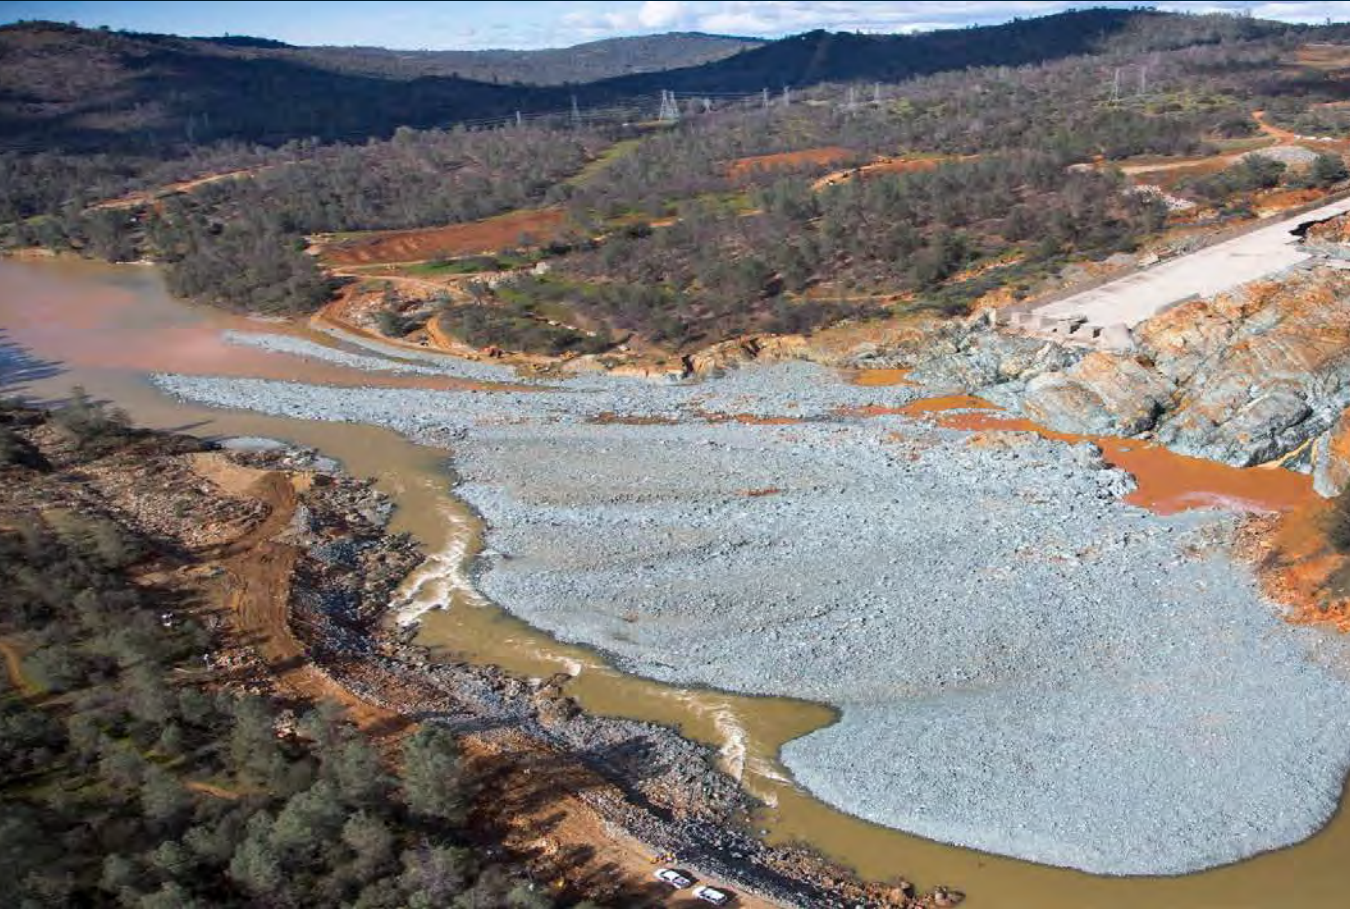
Debris Dam – Diversion Pool on February 27, 2017

Over 1.9 million cubic
yards removed in
9 days
36 land and barge
based excavators
32 heavy haul trucks

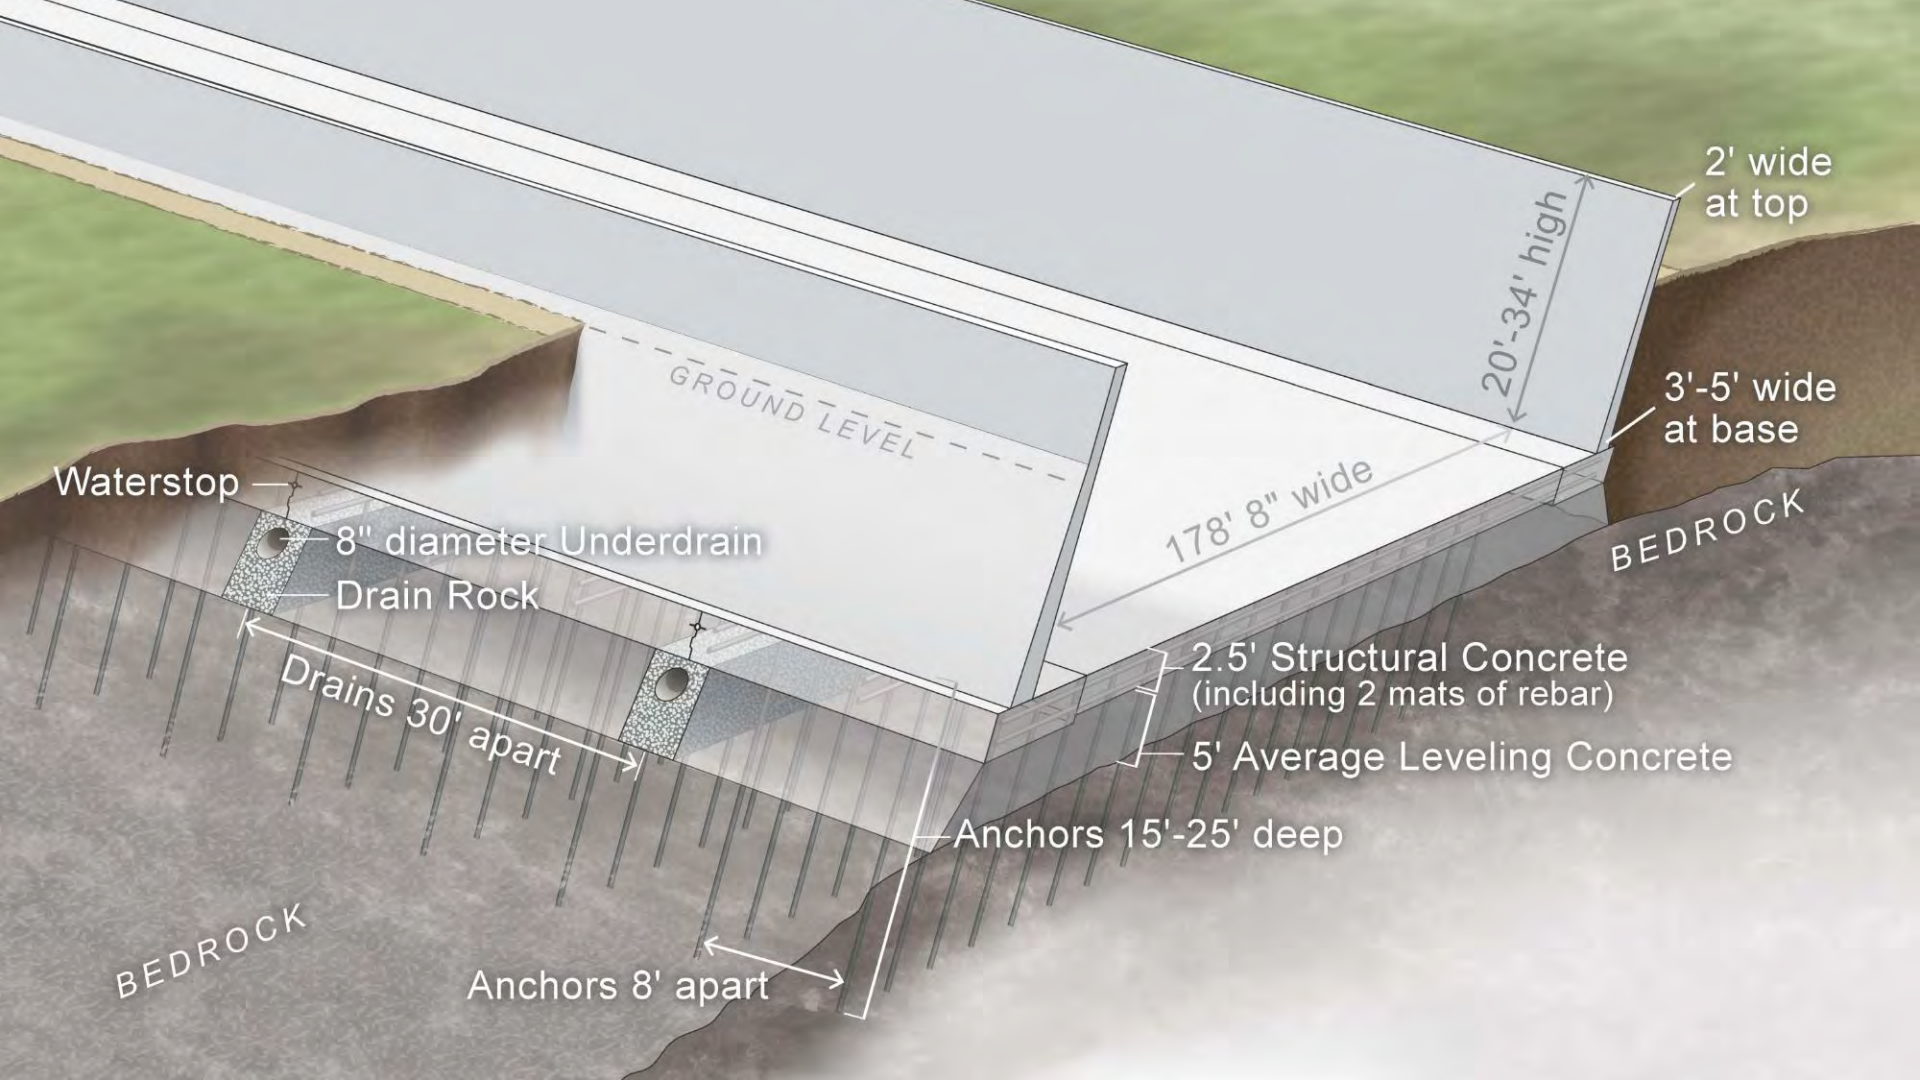
FCO Spillway Construction Sequence

2' wide
at top

20'-34' high

3'-5' wide
at base

8" diameter Underdrain

Drains 30' apart

2.5' Structural Concrete
(including 2 mats of rebar)

5' Average Leveling Concrete

Anchors 15'-25' deep

Anchors 8' apart

**Roller-Compacted
Concrete Splashpad**

**Roller-Compacted
Concrete Buttress**

**Underground
Cut-off Wall
(Secant pile wall)
1,450 ft long
35 - 65 ft deep**

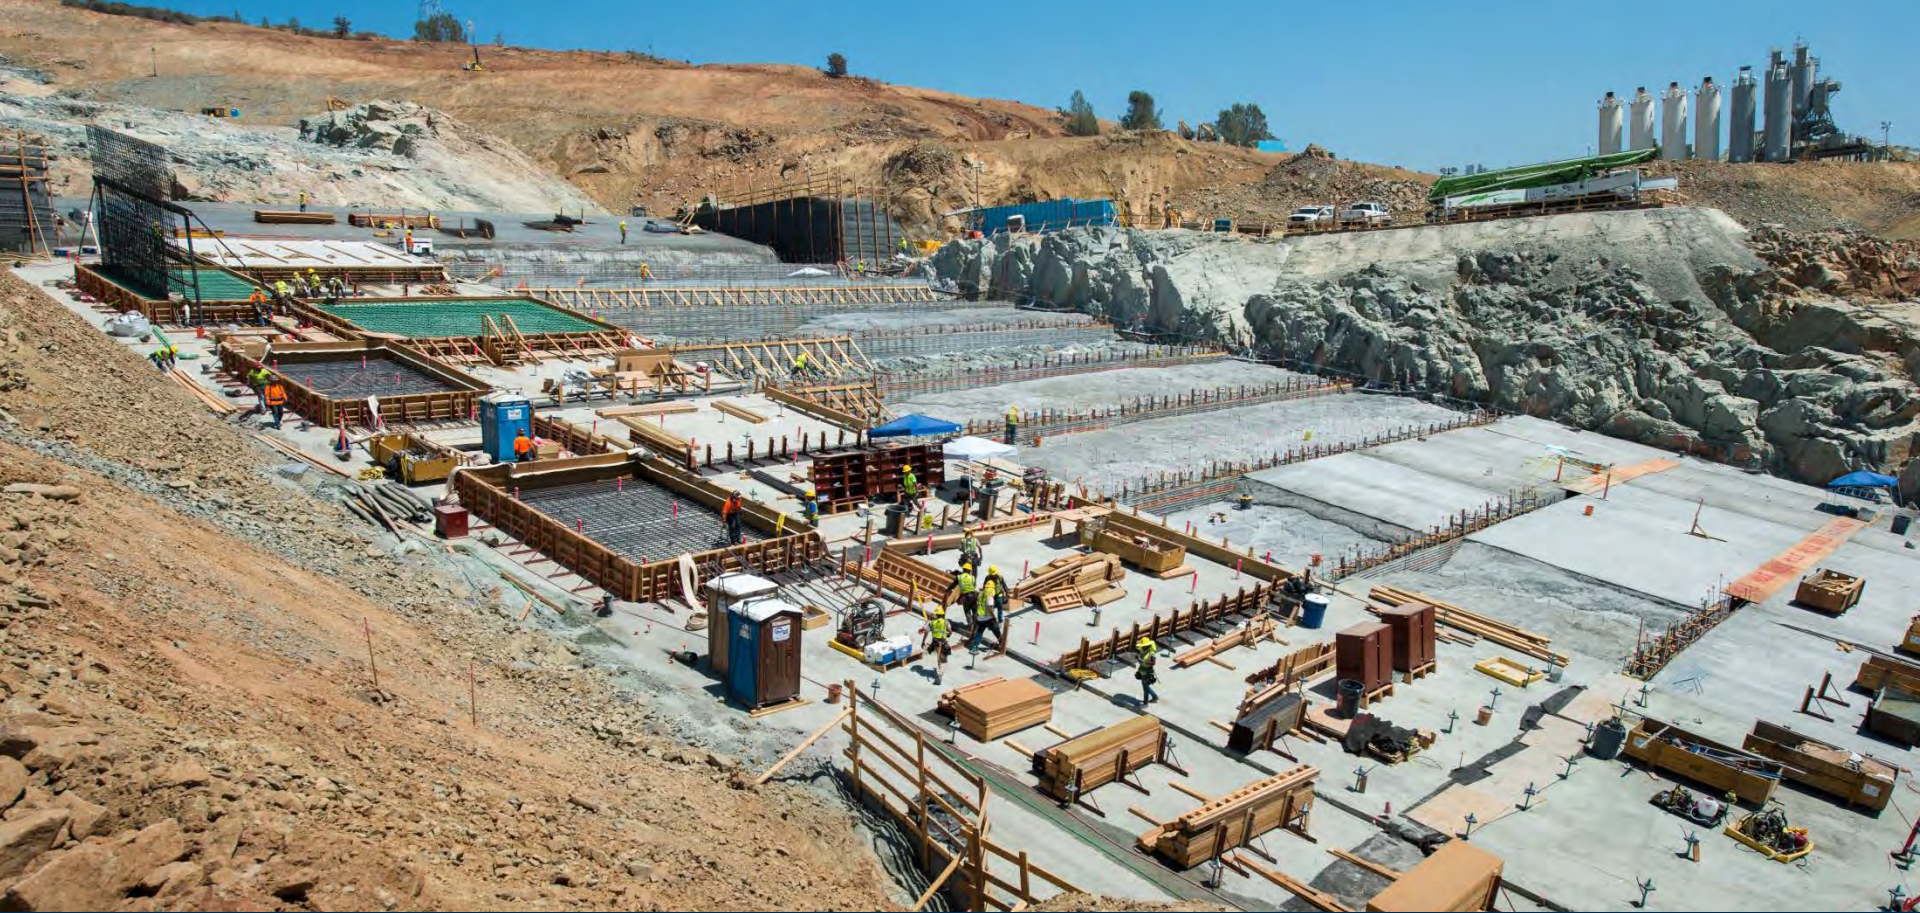
Leveling Concrete & Drains

55,000 feet of drain
pipes - stacked
vertically, would
stretch more than
10 miles high

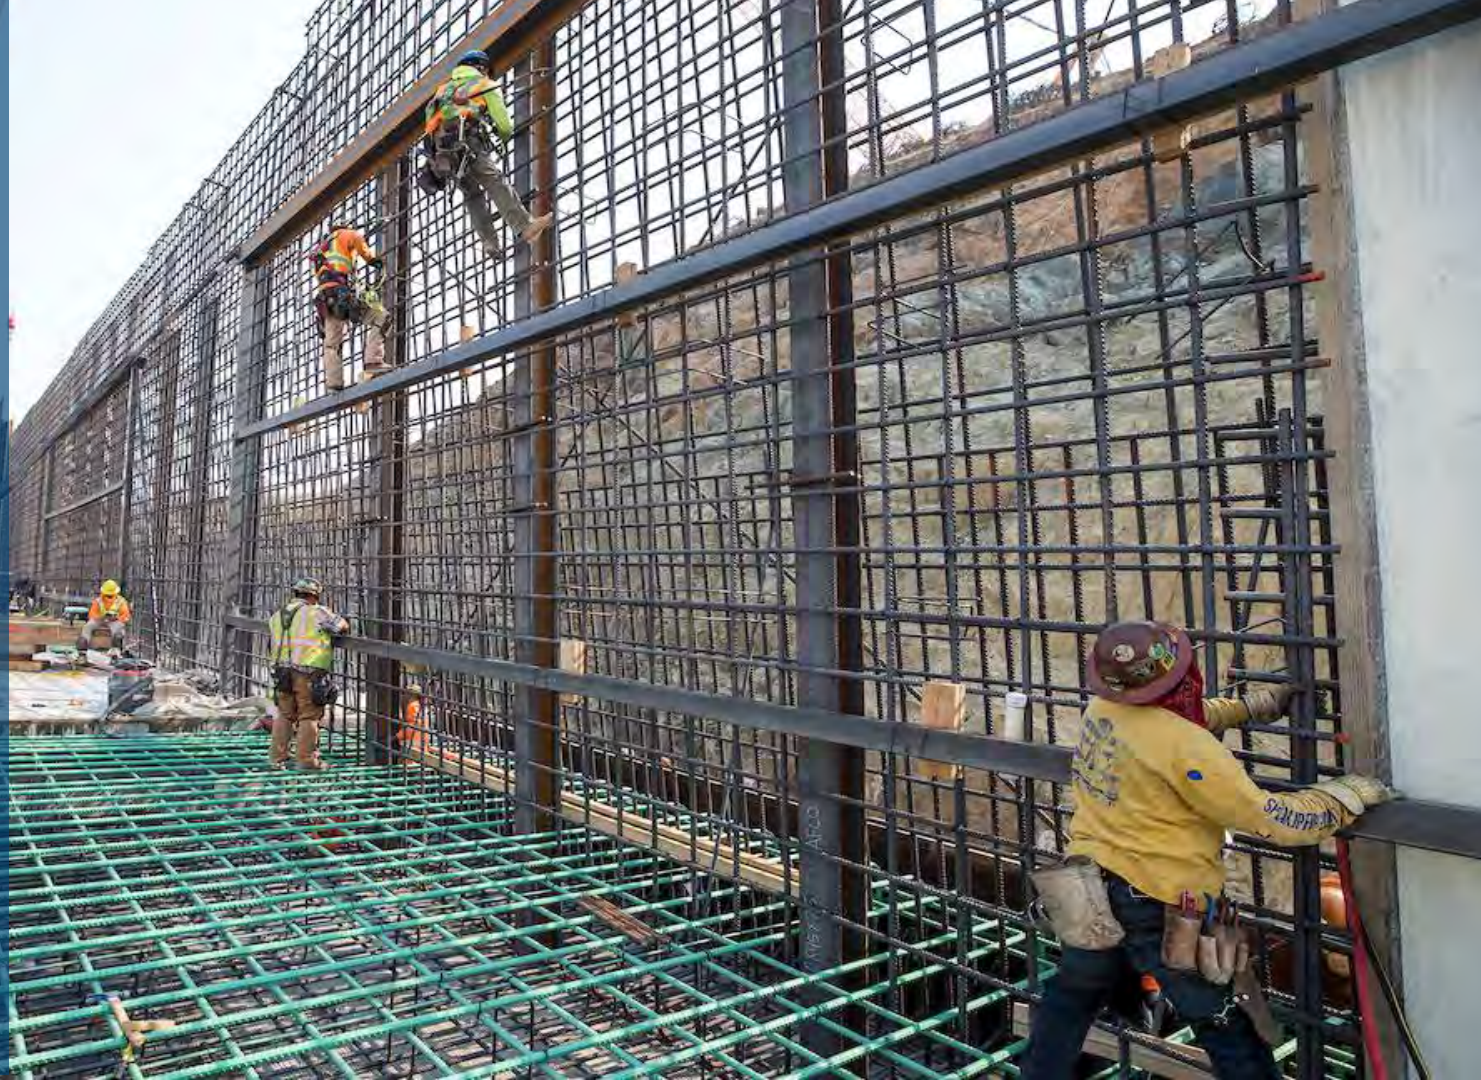
Main Spillway Upper Section

Structural rebar
panels

8,519,000
pounds of
reinforced steel

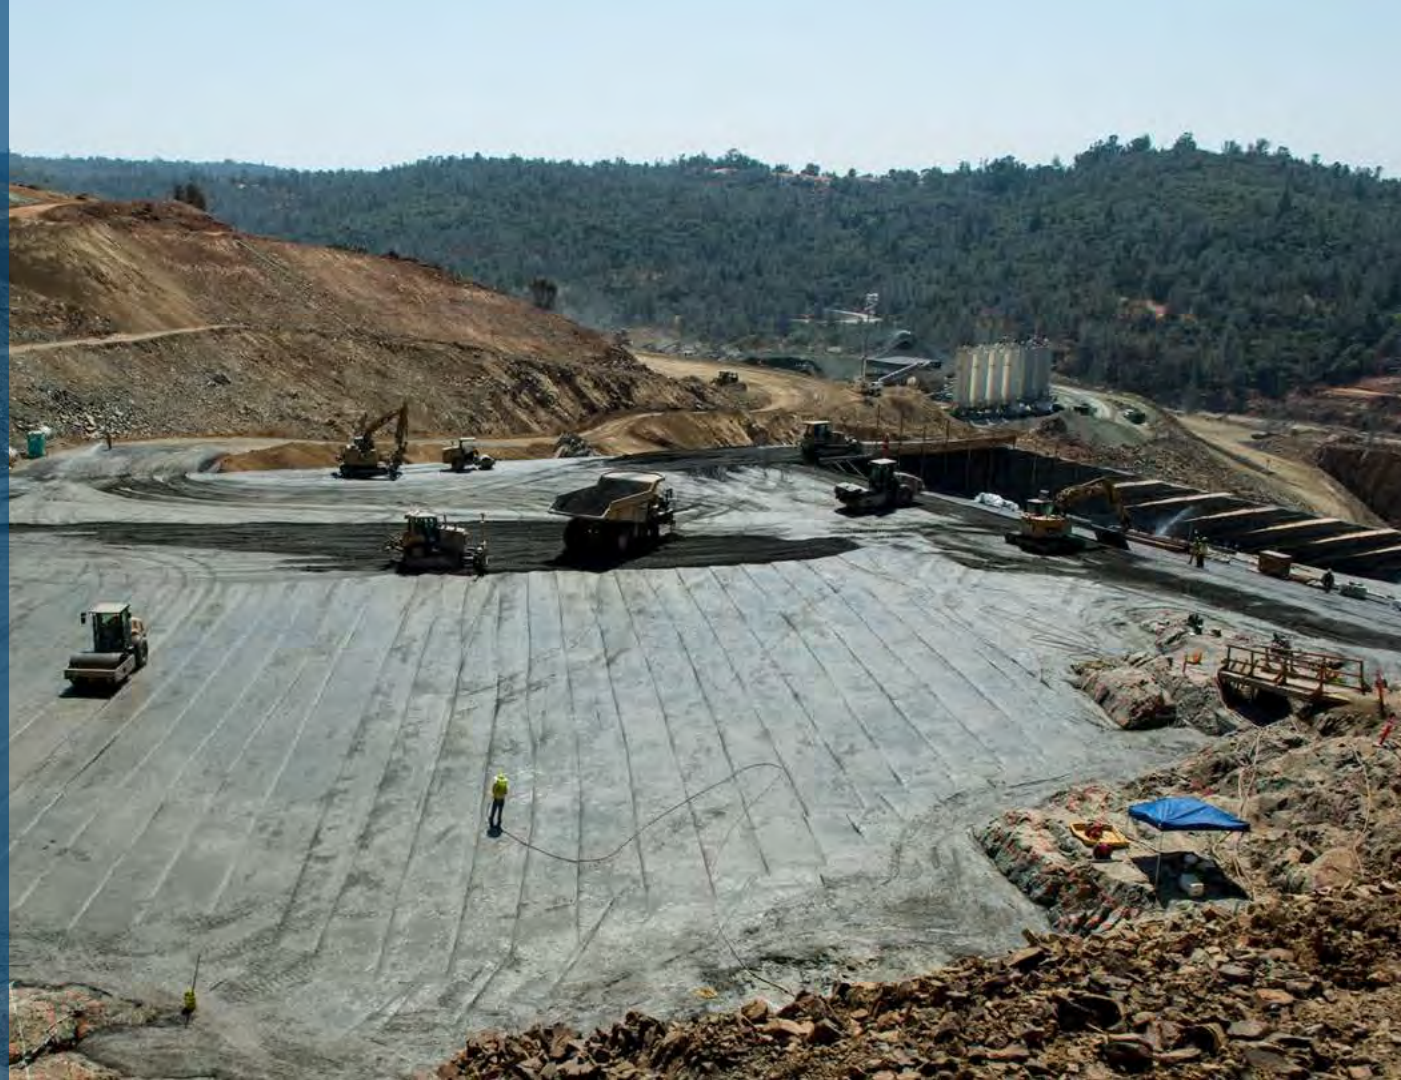
Main Spillway Middle Section

Building RCC
up to meet
structural
concrete

349,000 Cubic
Yards of
Roller Compacted
Concrete (RCC)

Every 5 minutes a dump
truck dropped off RCC
totaling more than 5,000
cubic yards a day

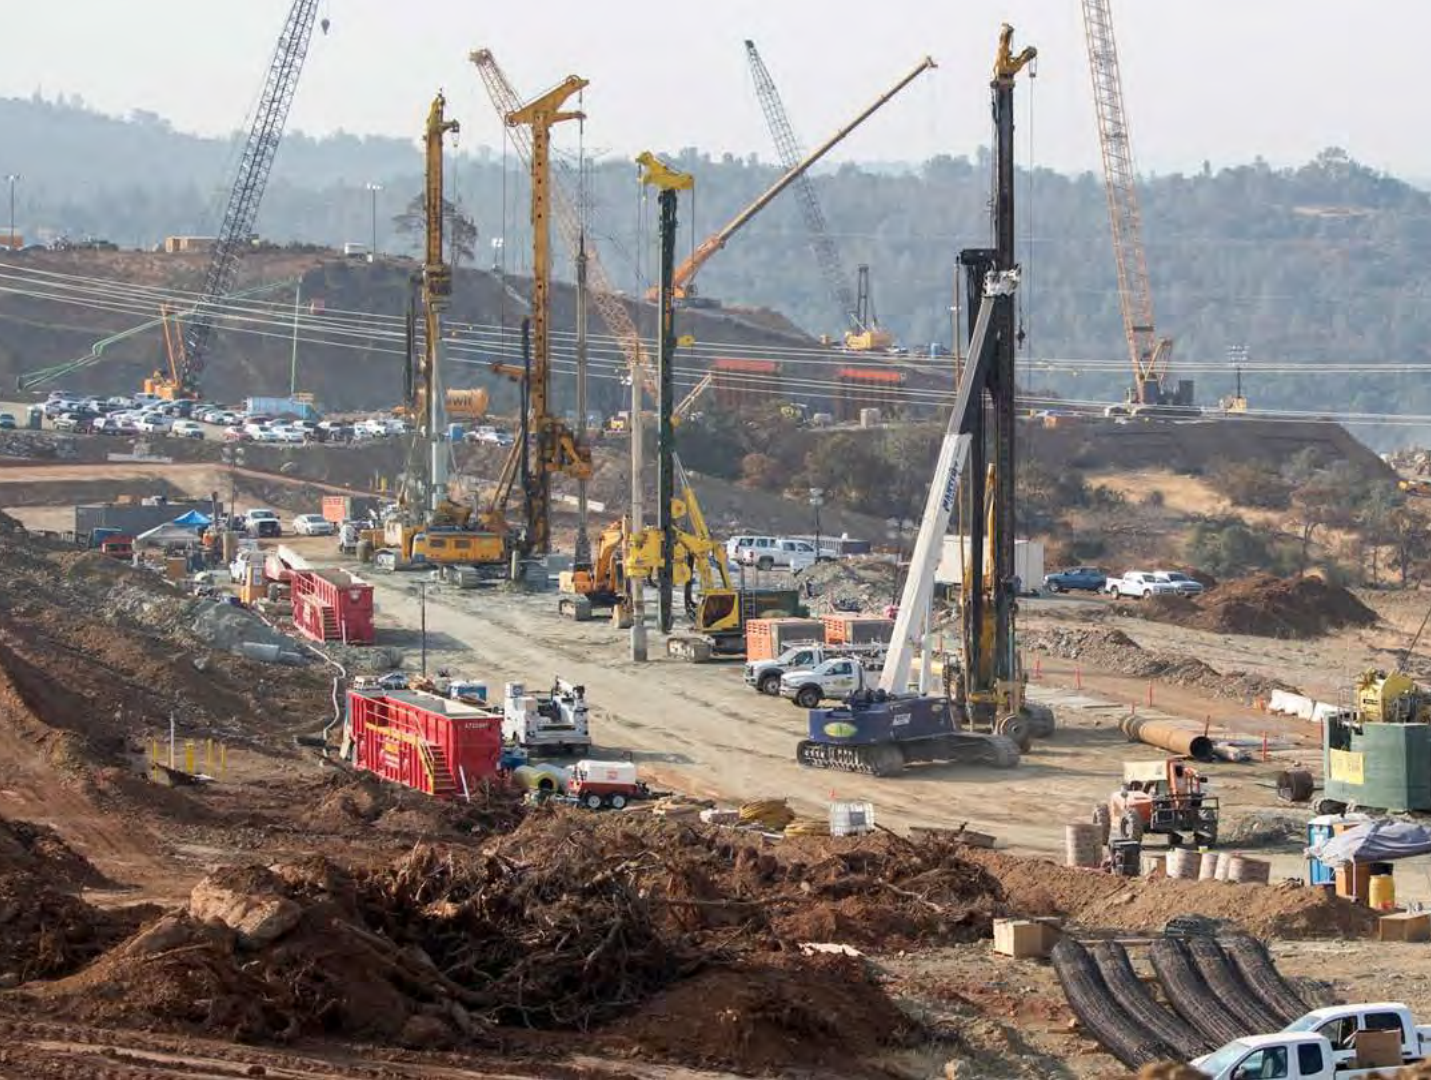
Emergency Crest Cut-off Wall

Secant Pile Wall

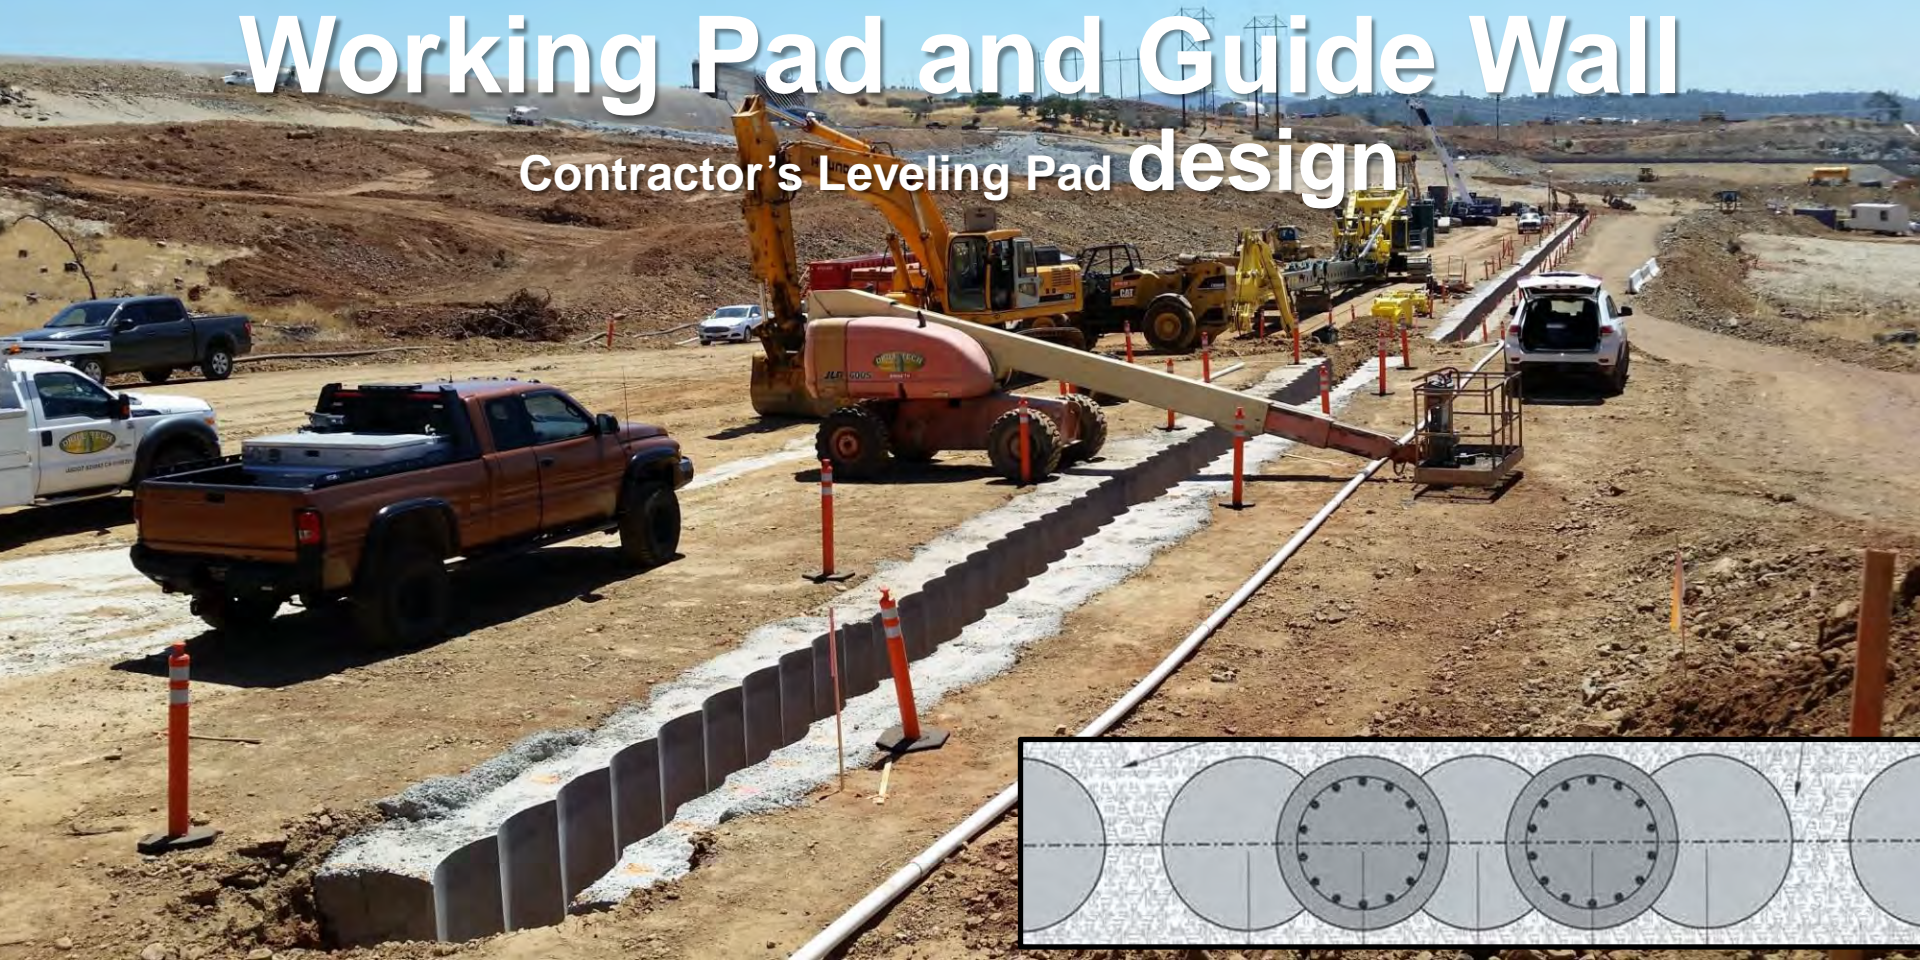
Secant Pile Wall Working Pad and Guide Wall

Contractor's Leveling Pad design
