# Fulfilling the Promise of San Diego's Purple Pipe Program

Hooman Partow, City of San Diego Todd Engstrand, HDR Eric Scherch, HDR

## 2018-2020 Recycled Water System Condition Assessment and Optimization Plan

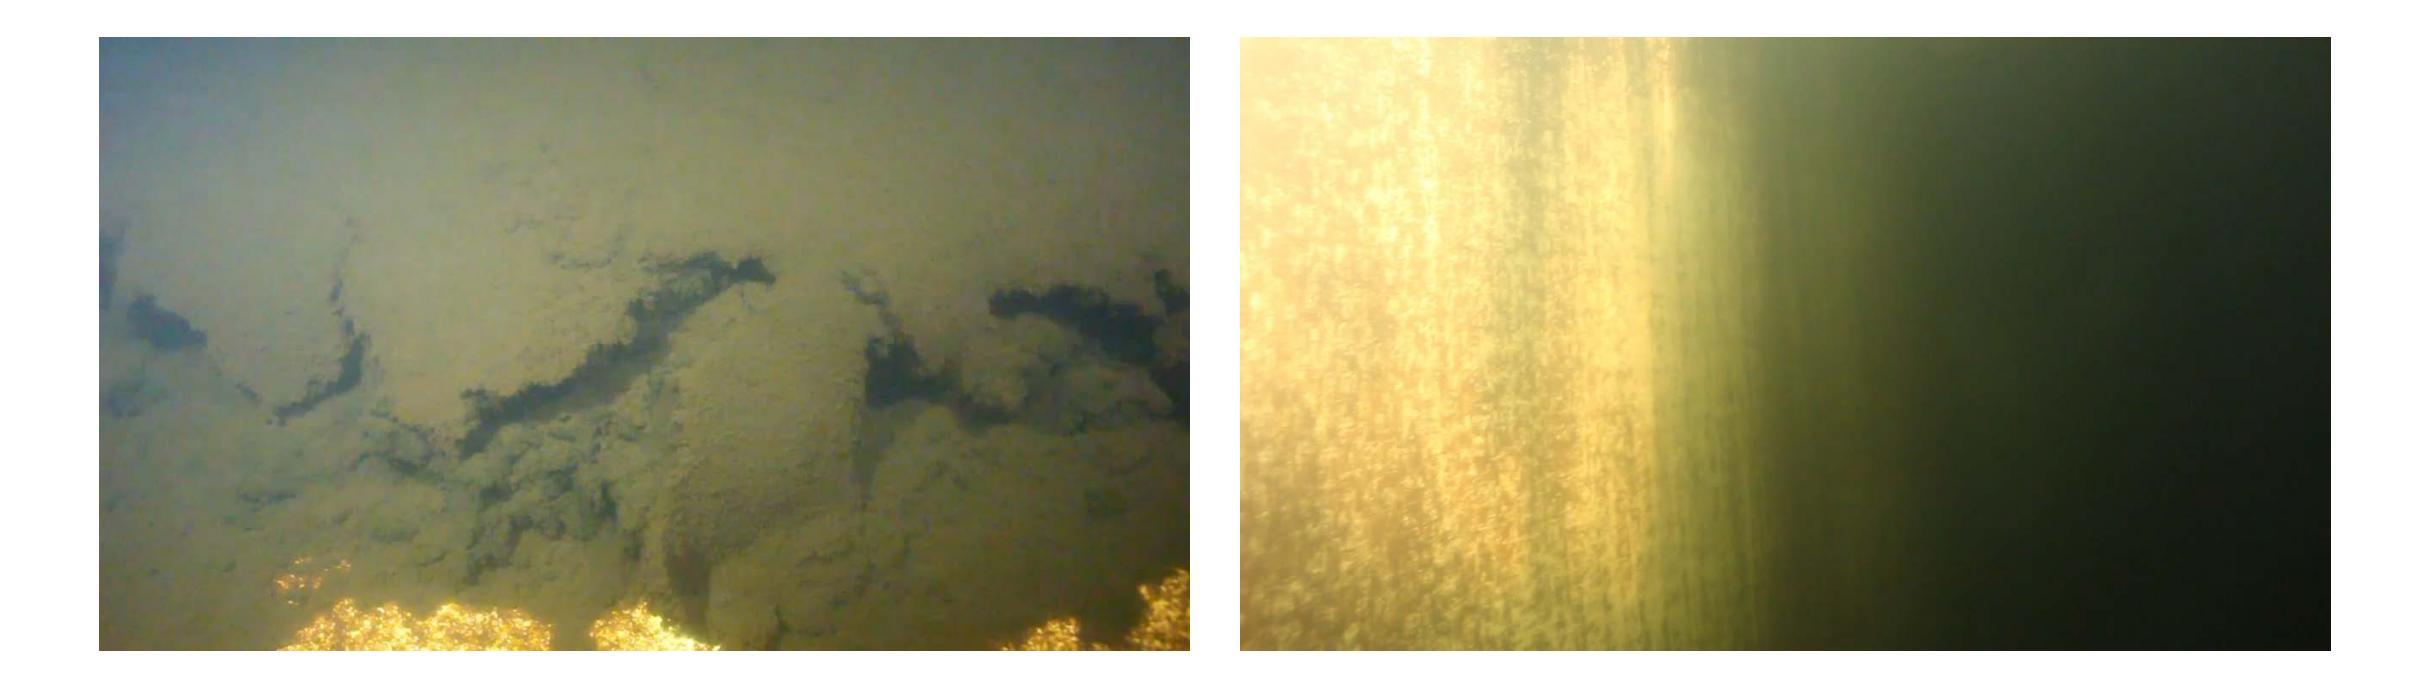
# Reservoir Diving, Cleaning and Inspection

What's important here...

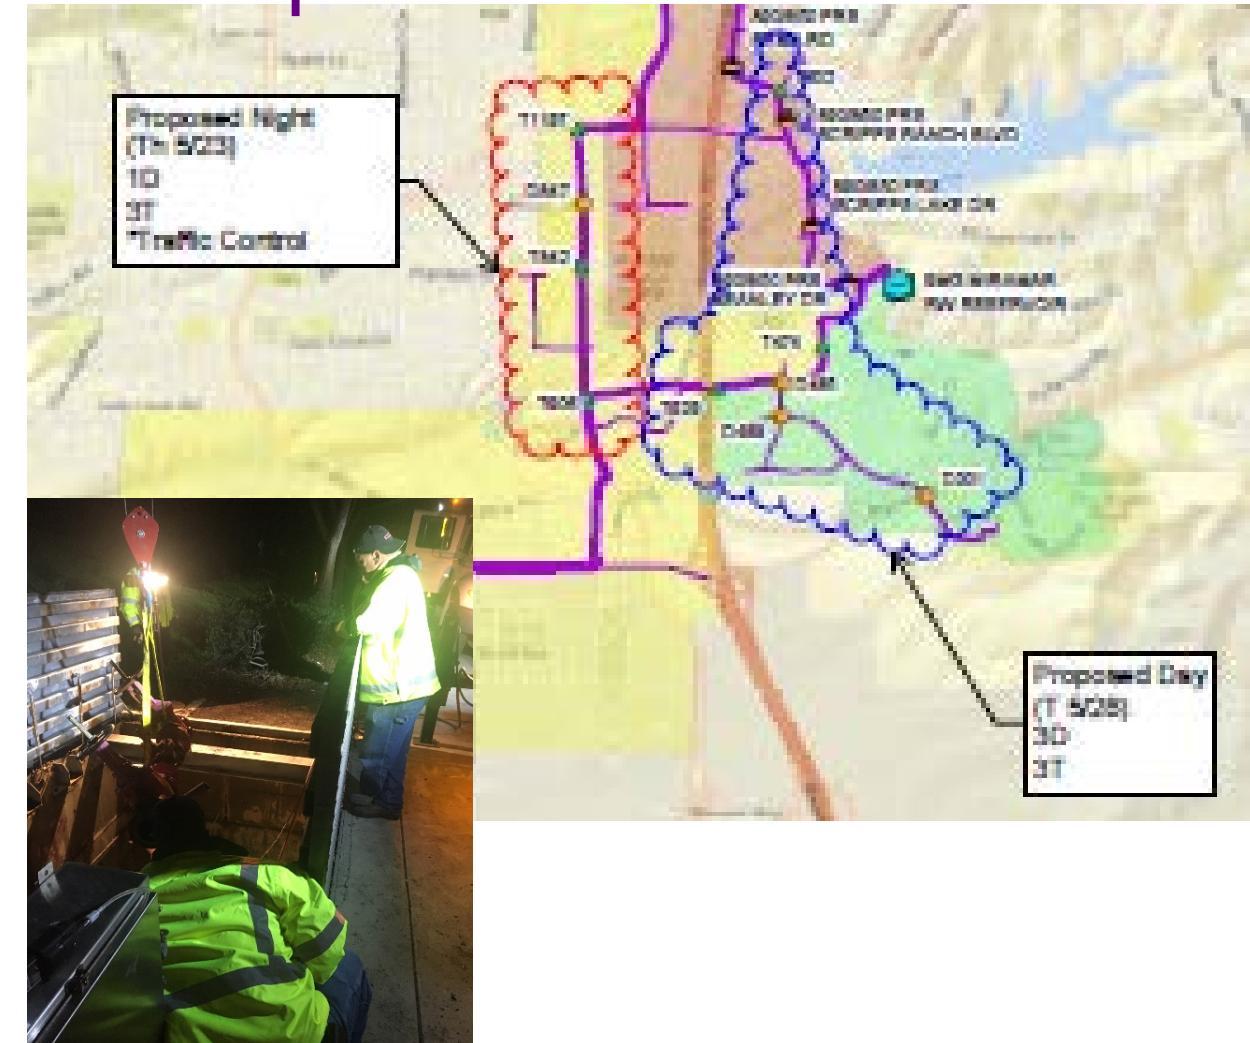
### Valve Inspections – What's Important?

- Coordination with operations
- Agreement on when and how to test
- Develop Plan B
- Work plan and schedule
- Coordination meetings before every week's operation

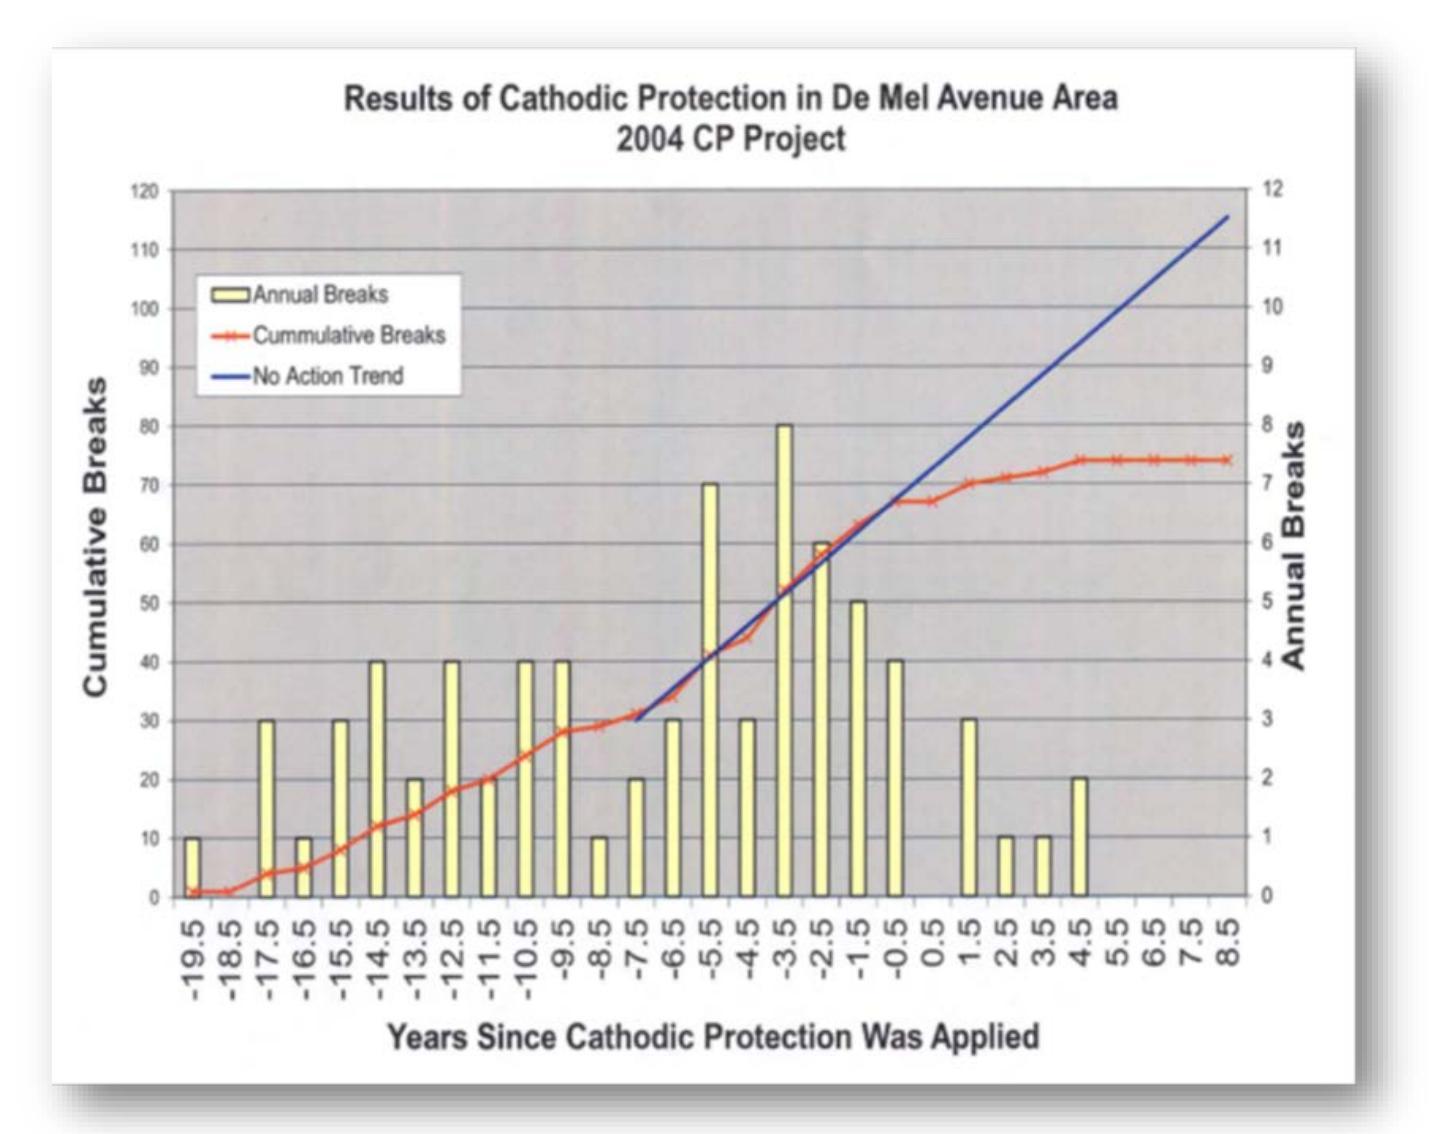
### **Cathodic Protection**

- AWWARF 2608
- External Corrosion and corrosion control of buried water mains
- Identified mains without CP
- Identified mains where potential readings did not meet NACE SP0169, Section 6.2.1.3 criteria
