# Continuous Flow Seawater RO System for Recovery of Silica-Saturated RO Concentrate

# WateReuse Research Foundation

WateReuse Research Foundation Project Number: WRF-09-12 WateReuse Research Foundation Product Number: 09-12-1

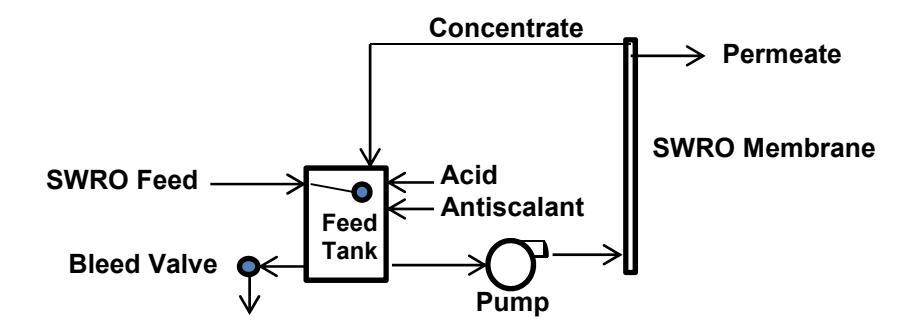
A simplified schematic diagram of the experimental setup is shown in Figure 3.1. Concentrate from the KBH desalting plant continuously flows into the 200-gal feed tank through a float valve. A scale inhibitor for controlling sulfates (Pretreat Plus 400) is added at a preset concentration based on the rate of flow into the feed tank (namely, on a flow-paced basis). At the start of the project, the concentration was set at 4 mg/L.

Figure 3.1. Schematic diagram of pilot plant setup.

Sulfuric acid addition was automatically controlled by feeding a 25% sulfuric acid solution to maintain the pH at a preset value, 3.9 in this study, to ensure that there would be no fouling due to carbonates. In addition to the pH probe, the feed tank was equipped with a conductivity probe that enabled the feed tank to be maintained at any preset value by opening and closing the bleed valve as necessary. The pressure vessel housed a single GE-Osmonics SWRO thin-film membrane Model AD 4040FM. The active area of the membrane was 86 sq ft (sf) with an average NaCl rejection capacity of 99.6% (under standard conditions as tested by the manufacturer). The operating parameter of maximum pressure drop over a single element is 12 psi. A schematic diagram of the membrane is shown in Figure 3.2, with A, membrane length, at 40 in., B, diameter of the permeate tube, at 0.75 in., and C, outside diameter of the membrane, 3.9 in.

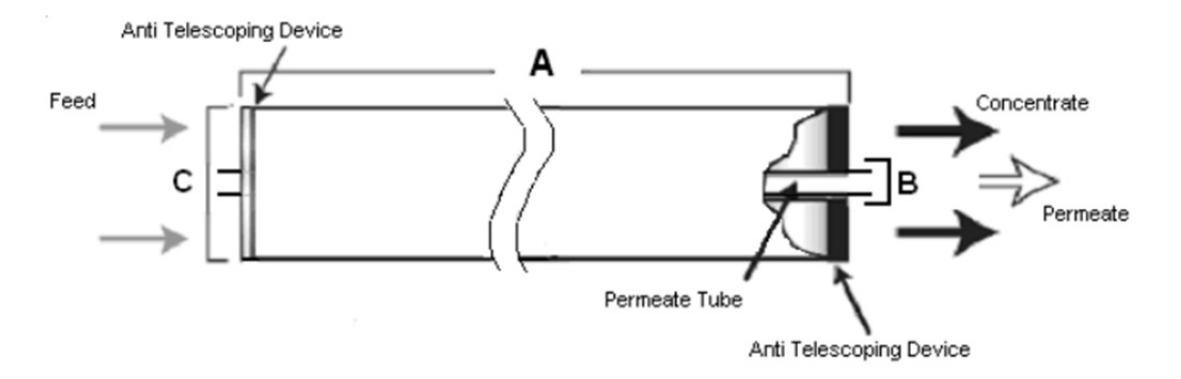
**Figure 3.2. Schematic of SWRO membrane.** Source: Fact Sheet, AD Series, Seawater RO High Rejection www.gewater.com/products/consumables/pure\_water\_elements/index.jsp

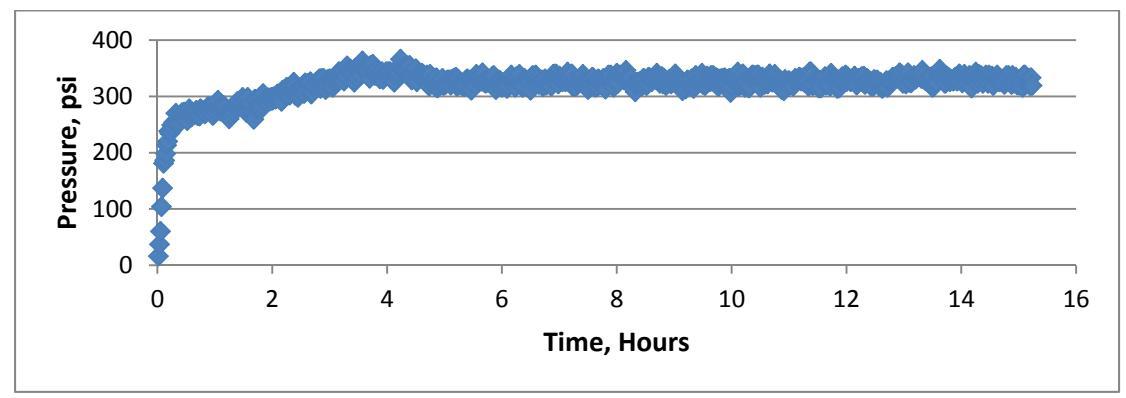
Figure 5.1 is a plot of transmembrane pressure versus time for the first 15 h after startup at a recovery of 48%. The pressure was essentially constant after the feed tank conductivity reached the preset value of 30,000  $\mu$ S/cm (corresponds to a TDS concentration of approximately 20,000 mg/L), approximately 4 h after the system was started. For the purposes of this research project, because the feed tank and discharge point are both operated under atmospheric conditions, the terms "transmembrane" pressure and "feed" pressure are essentially the same.

Figure 5.1. Transmembrane pressure for first 15 h after startup at 48% recovery, with a preset value of 30,000 µS/cm, in terms of feed tank concentration.

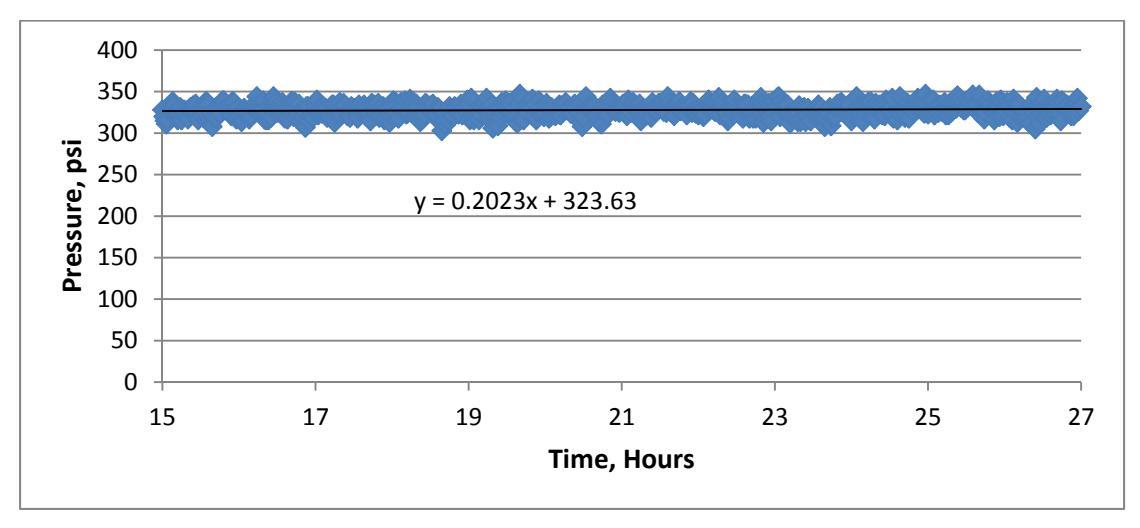
Figure 5.2 is a plot of transmembrane pressure versus time after the first 15 h of run time. The pressure was already starting to increase as evidenced by the slight upward slope (namely, 0.2023) of the best fit line. The pilot membrane system was designed to automatically shut down operation at a prescribed, or preset, pressure. Before the end of the second day, the pressure reached 800 psi and the system automatically shut down. Inspection of the feed tank revealed a significant amount of precipitate on the sides and bottom of the tank. Wet chemical analysis and X-ray diffraction indicated that the precipitate was calcium sulfate. Previous electron microscope analyses of precipitate in the batch-treatment concentrate revealed the same results plus a small amount of silicon. It is not known whether the precipitation began in the membrane or in the tank, but once precipitate was present in either

Figure 5.2. Transmembrane pressure after first 15 h at 48% recovery, with preset conductivity value of 30,000 µS/cm, in terms of feed tank concentration.

place, the calcium sulfate crystals would likely have served as a seed, resulting in enhanced precipitation. It is possible that use of a cartridge filter before the membrane could have reduced this problem, if precipitation occurred only in the feed tank.

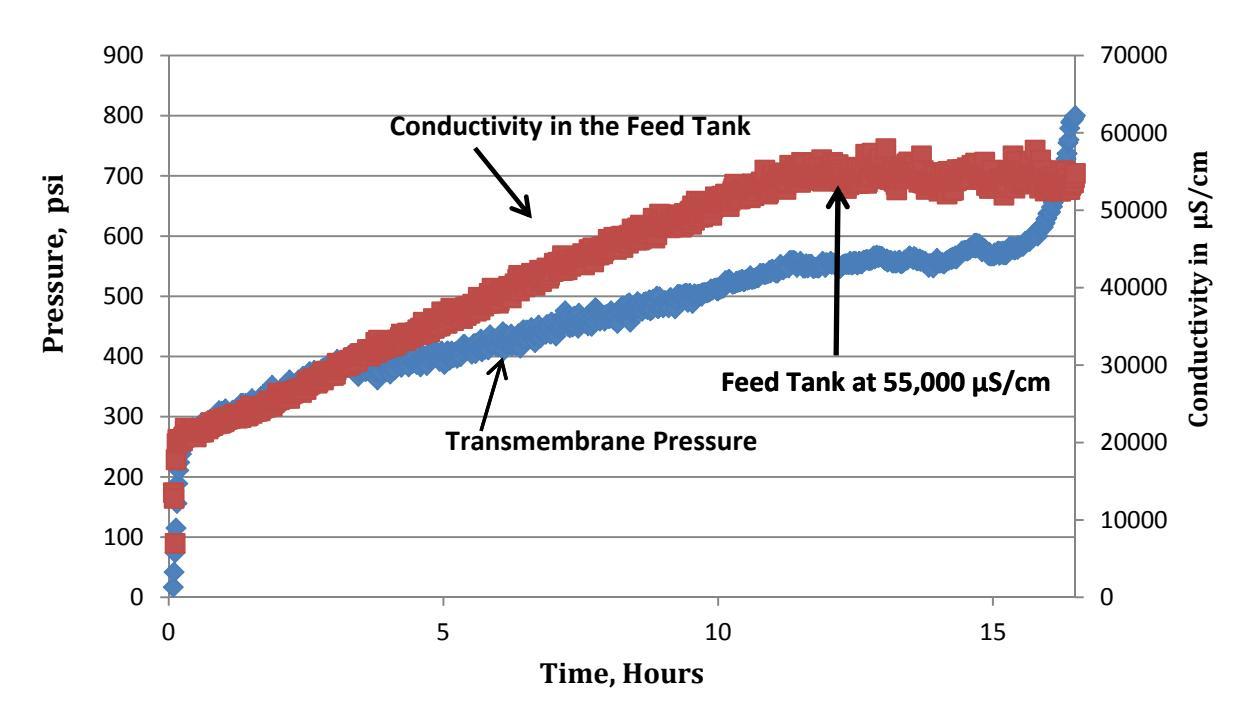
Figure 5.3 is a plot of transmembrane pressure and conductivity versus time for a feed tank conductivity setting of 55,000  $\mu$ S/cm (corresponds to a TDS of approximately 35,000 mg/L). It took approximately 12 h for the feed tank conductivity to reach the preset value of 55,000  $\mu$ S/cm as shown on the graph. Thereafter, the transmembrane pressure remained relatively constant (at about 530 psi) for only 3 h, after which it steadily increased. During the last 30 min of operation, the transmembrane pressure increased very rapidly, going from 600 to 800 psi, causing the system to automatically shut down because of high pressure.

Figure 5.3. Transmembrane pressure and conductivity at 55,000-µS/cm recovery.

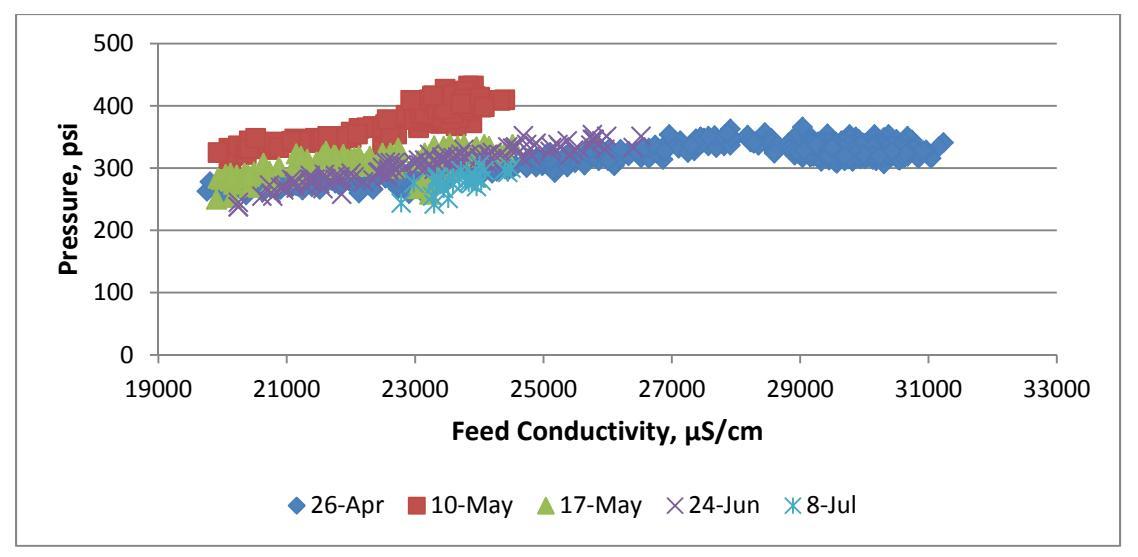
Figure 6.1 shows the transmembrane pressures for five different events: (a) prior to any membrane fouling events (namely, April 26), (b) while the membrane was fouled (namely, May 10), and (c) after the membrane had been cleaned following three different fouling events (namely, May 17, June 24, and July 8). In all cases, the transmembrane pressures were about the same after chemical cleaning as they were before the membrane was ever fouled, indicating that the foulant was indeed primarily calcium sulfate. The cleaning method was always the same for each and every date represented on Figure 6.1. The purpose of this figure is to portray system test conditions (pressure and feed conductivity) prior to and during membrane fouling events, as well as after chemical cleaning of the membrane. Review of the figure indicates that cleaning of the membrane returns the membrane to a condition that approximates the condition existing prior to fouling, at least in terms of system pressure and feed conductivity.

Figure 6.1. Membrane pressures before and after chemical cleaning. April 26 data points represent conditions prior to membrane fouling. May 10 data points represent a fouled membrane condition. May 17, June 24, and July 8 data points represent conditions after membrane cleaning events.

It should be pointed out that, once an element is fouled with CaSO<sub>4</sub>, all the nucleation sites may not be removed during cleaning. Thus, the membrane may subsequently foul more quickly under supersaturation conditions because of the presence of these nucleation sites, resulting in fouling of the cleaned membrane surface occurring more quickly than fouling of a new one. Whether this factor was significant in this project is not known.
